## Field campaign

<b>Topic</b>	Bentayga - Front Lower Grille Replacement (SC16/35)
<b>Market area</b>	Bentley: worldwide (2WBE),Hongkong-Macau (5HK)
<b>Brand</b>	Bentley
<b>Transaction No.</b>	2045782/2
<b>Campaign number</b>	EA73
<b>Note</b>	
<b>Type</b>	Workshop Campaign
<b>US code</b>

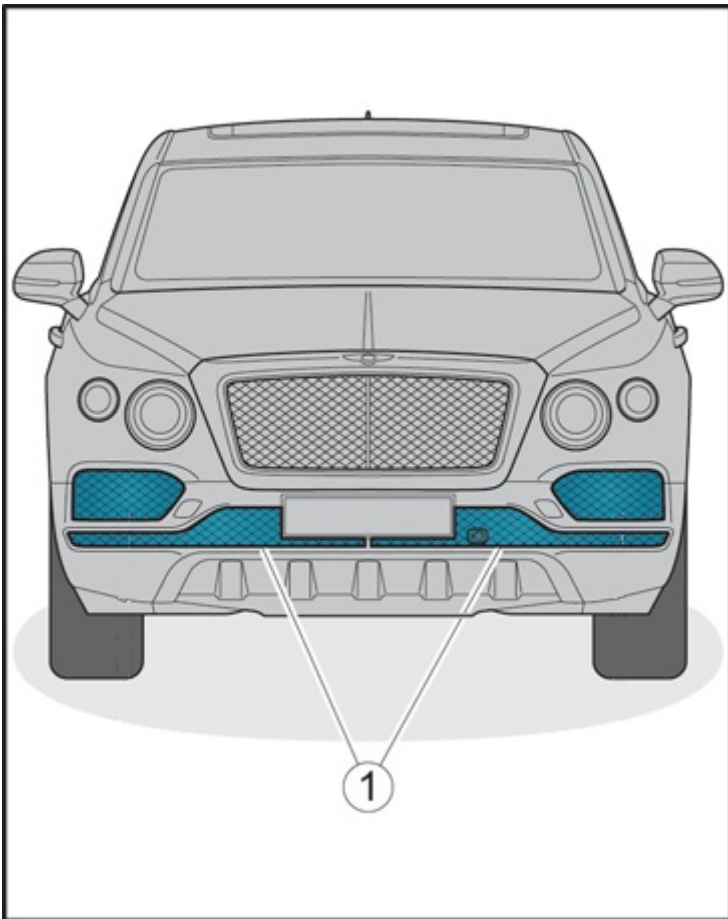
Figure 1.

On a small number of Vehicles front bumper grilles have been modified to prevent false obstacle warnings from the Park Distance Control (PDC) system, there is a possibility that the chrome effect finish may have been damaged during modification, this may lead to corrosion in the surrounding area.

Replace the two lower front Grilles – figure 1.

Replace lower front Grilles – item 1 - with new parts – Refer to Repair Group 63 *Front Bumper Grilles – To Remove and Fit* – figure 1.

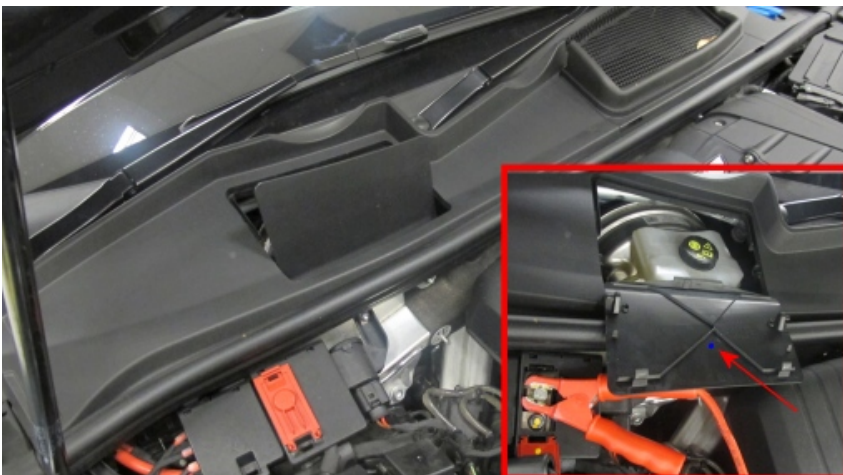
Figure 2

If the vehicle is not already listed in the "Repair History" (Elsa Pro) check for the Blue Campaign identification mark on the underside of the service cover for the Brake Fluid Reservoir – figure 2.

Blue campaign completion mark to the underside of the service cover for the brake fluid reservoir – figure 2.
