# **Technical Service Bulletin**

Topic Steering rack noise during extended city drive				
Market area	Bentley: worldwide (2WBE),Hongkong-Macau (5HK)			
Brand	Bentley			
Transaction No.	2046733/2			
Level	EH			
Status	Released for publishing			
Release date	Mar 8, 2017

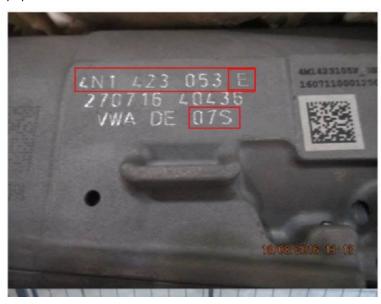
Figure 1

The example figure 1 details the steering rack part number and code on the body of the unit. In this example the part number is 4N1423053E and generation code is 07S this generation code is higher than 06S therefore this part would not have to be replaced in respect to the symptom detailed in this TPI

In the event of the above customer complaint, then check the steering rack part number. A steering rack with part number 4N1423053E and a generation code of 06S or lower is suspect and should therefore be changed if the symptom detailed in this TPI has been reported by the owner.
