## Technical product information

<b>Topic</b>	Tailgate (Rear lid) power open / close function sporadic or inoperative
<b>Market area</b>	Bentley: worldwide (2WBE),Hongkong-Macau (5HK)
<b>Brand</b>	Bentley
<b>Transaction No.</b>	2047170/1
<b>Level</b>	EH
<b>Status</b>	Approval
<b>Release date</b>

Tailgate (Rear lid) power open / close function sporadic or inoperative

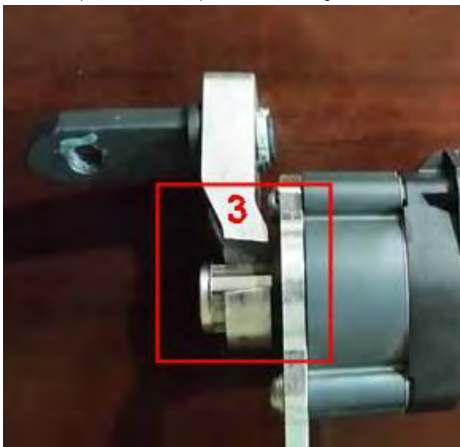
Figure 1

Tailgate motor output link structural failure has been reported. Bentley Engineering request further detail to establish root cause.

2. Attach a photograph of damaged output link, Note: check both right hand and the left hand motor output links see example figure 1
