# Technical product information

<b>Topic</b>	Bentayga - Illuminated Sill Trim Strip - Wiring Harness Correction
<b>Market area</b>	Bentley: worldwide (2WBE),Hongkong-Macau (5HK)
<b>Brand</b>	Bentley
<b>Transaction No.</b>	2046984/1
<b>Level</b>	EH
<b>Status</b>	Approval
<b>Release date</b>

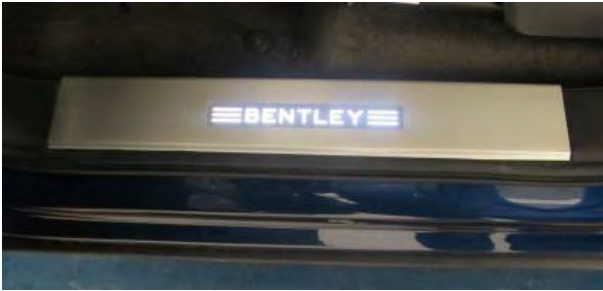
A number of illuminated Sill Trim Strips have been manufactured with incorrectly wired ribbon cable connectors, vehicles fitted with these parts have had harness connectors reconfigured to enable illumination.

Replacement illuminated Sill Trim Strips will be supplied with correctly wired ribbon cable connectors, corrective action may therefore be required when installing new parts to affected vehicles.

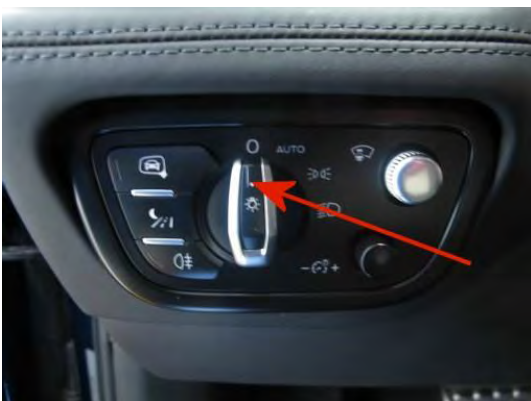
Figure 1

**Electrical power to Sill Trim Strips may automatically switch off after approximately twenty minutes, cycling the main lighting switch will restore the power supply – figure 1.**

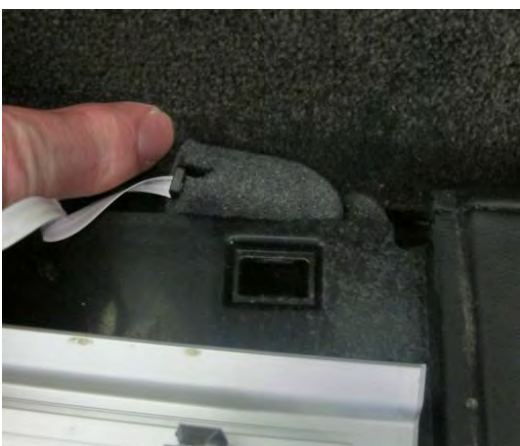
Figure 2

**Note:** The Sill Trim Strip connector may be located under the Sill Trim Strip substrate, reposition the carpet to aid removal – figure 2.

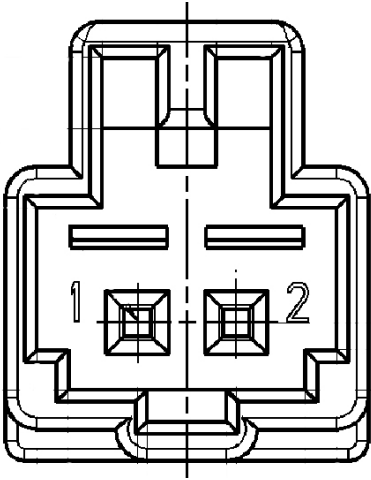
Figure 3

Using a suitable tester, measure the voltage at the harness connector, terminal numbers should be visible within the harness connector – figure 3.

▪ **Terminal 1 is Negative – wire colour *Brown***

**Terminal 2 is "12" Volts Positive – wire colour *Purple / Green***

If "12" volts is present at the connector but the wire colours are in the wrong cavities, continue with this document. If "12" Volts is not present, determine the cause, then if required, carry out the following instructions.
