Technical product information

Topic	Bentayga - Tailgate power latch fails to operate
Market area	Bentley: worldwide (2WBE),Hongkong-Macau (5HK)
Brand	Bentley
Transaction No.	2047235/1
Level	EH
Status	Approval
Release date

Bentayga - Tailgate power latch fails to operate

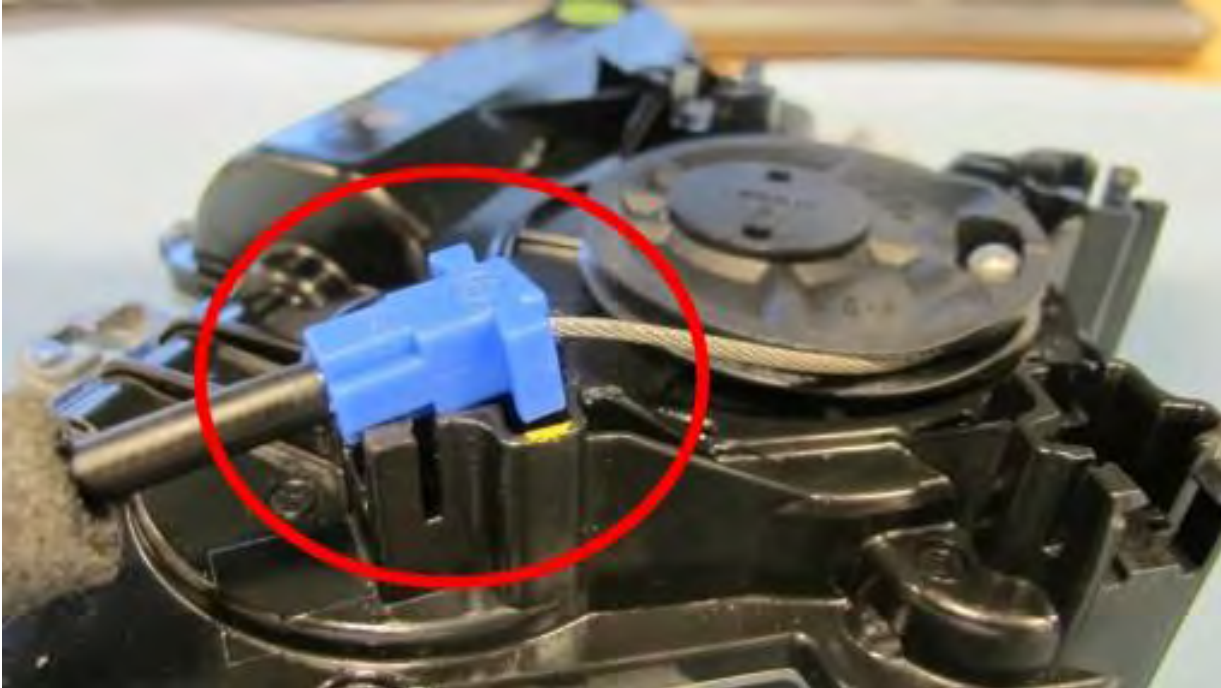
Figure 1

Bowden cable has detached from the Tailgate power latch actuator.

In certain circumstances, the Bowden cable used to power latch the tailgate may become detached from the power latch actuator – figure 1.

Introduction of a cable tie to prevent the Bowden cable detaching from the power latch actuator, an improved securing method is currently under investigation.

With a confirmed report of a tailgate powering closed but NOT power latching, check the integrity of the Bowden cable attached to the tailgate power latch actuator – figure 1.

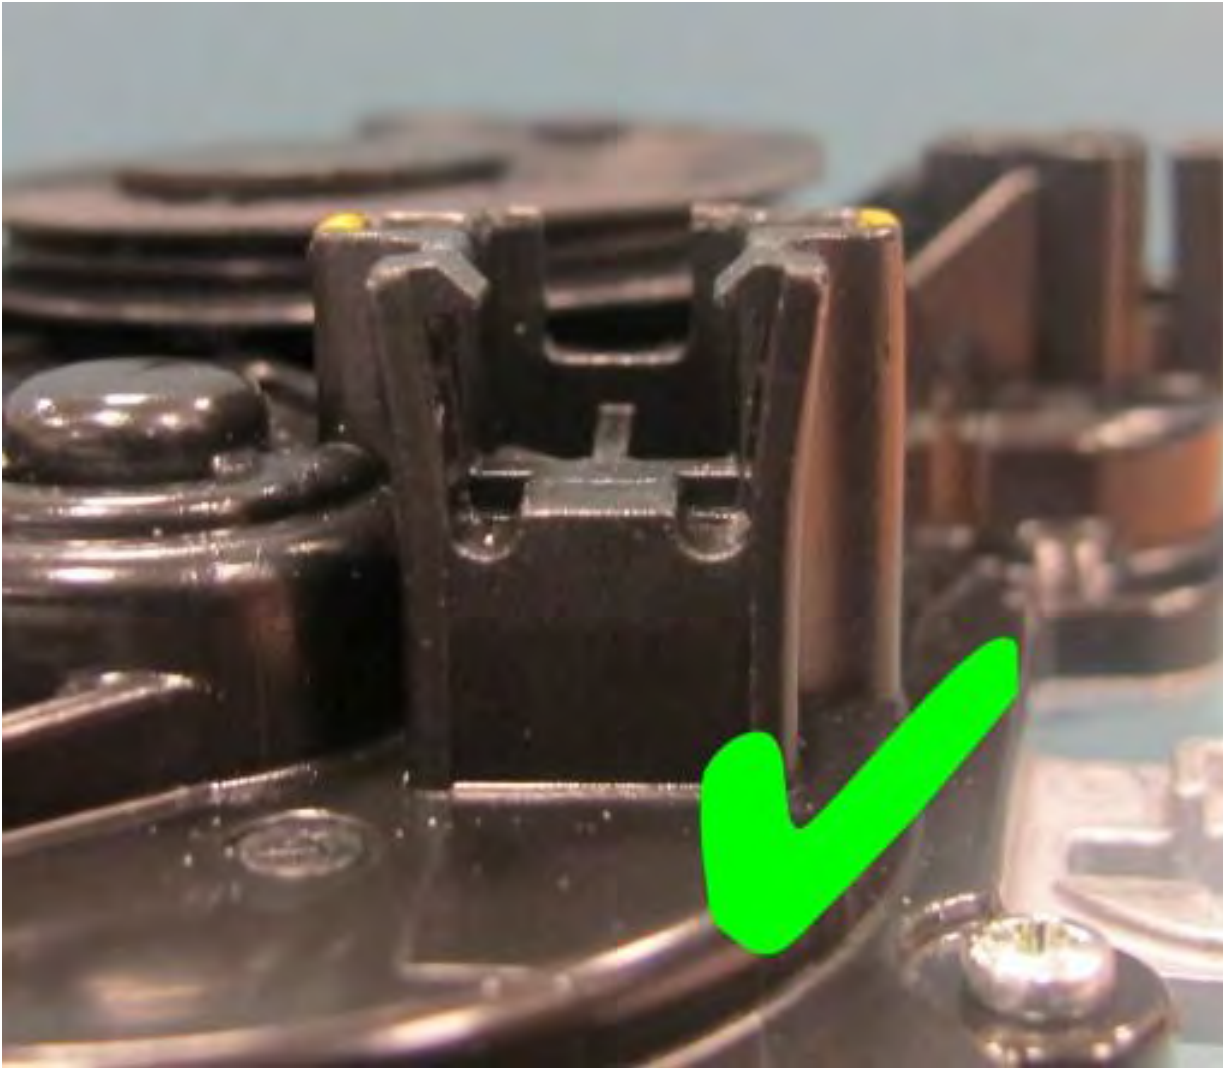
Figure 3

If the Bowden cable is detached from the actuator – figure 1 - inspect the securing tangs for damage – figure 3 - tangs that are slightly deformed are acceptable, broken or missing tangs will require the power latch actuator to be replaced – refer to **Repair Group 55 – Bonnet, flaps, cab, central**

locking – Tailgate and fittings – Tailgate power latching motor – To remove and fit.
