Field campaign

Topic	Bentayga - Left hand sunroof drain tube blockage (SC16/30)
Market area	Bentley: worldwide (2WBE),Hongkong-Macau (5HK)
Brand	Bentley
Transaction No.	2045705/1
Campaign number	EA68
Note	
Type	
US code

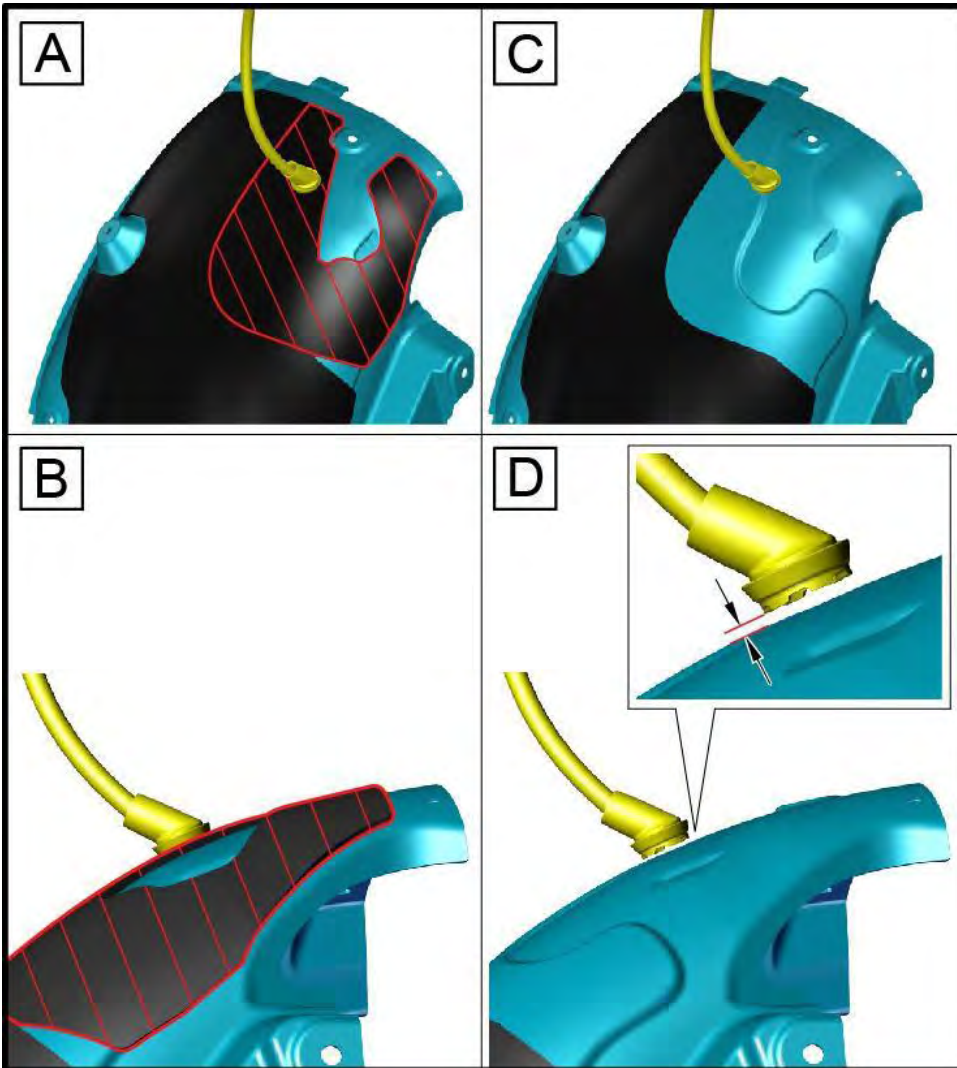
The sound proofing material (fitted to the back of the left rear wheel arch liner) and the drain port located in the left rear wheel arch body panel are positioned in close proximity to each other.

The sound proofing material can restrict the water flow exiting through the left hand sunroof drain.

Referring to Figure 1

- Points A and B (lined area) show the drain tube in relation to the excess material fitted to the rear of the wheelarch liner
- Remove the excess material using a suitable cutting tool in the lined area only

- Once the excess material is removed, the area in which the vent pipe exits the left hand wheelarch body panel should look as shown in C and D once refitted.

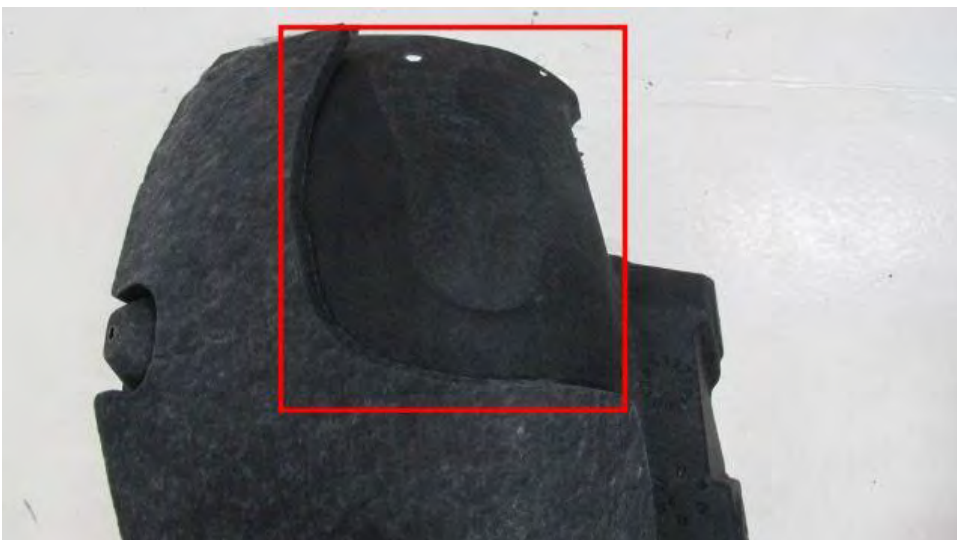
Figure 2

Figures 2 and 3 show the arch liners after modification

The gap created between the wheel arch liner and the vent will allow the water to drain without any restriction

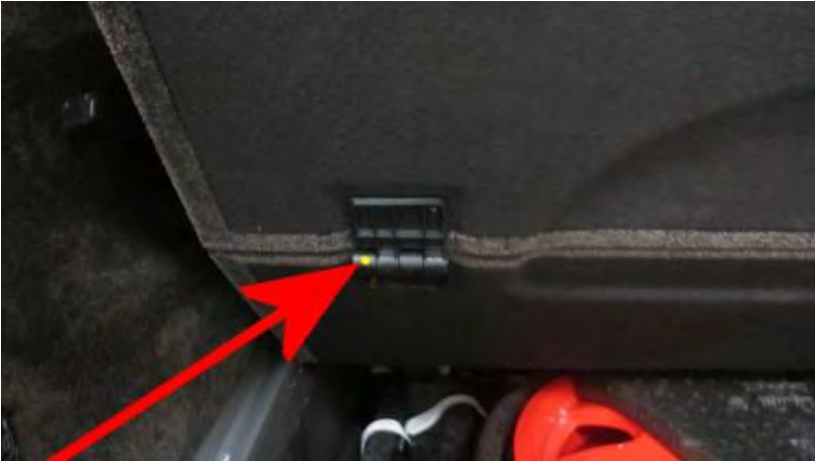
Figure 6

Yellow paint mark on the left hand boot floor hinge

9. On completion place a yellow paint completion mark on the left hand boot floor hinge (Figure 6)
