**** CONFIDENTIAL ****
Technical Service Bulletin 2017-0962

DATE: July 5, 2017
TO: E-ONE Dealers and Customers
FROM: Kevin Kearns, Customer Support Manager
SUBJECT: Reyco Upper Shock Mounting Hardware

Reyco Upper Shock Mounting Hardware Inspection and Repair (E-One TSB #2017-0962, Reyco-Granning TSB USM 0217)

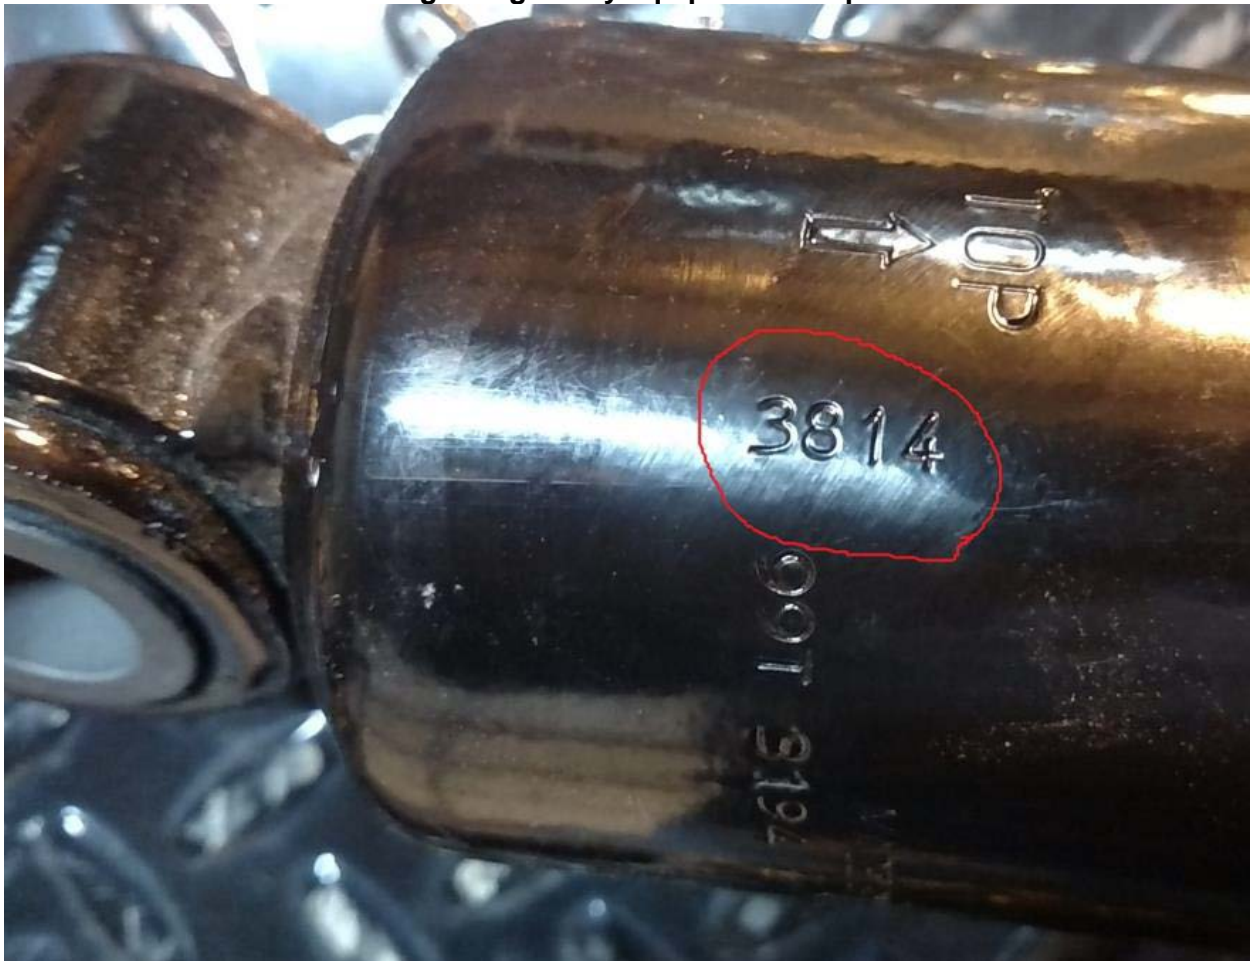
Condition: The upper shock mounting hardware may include spacers made of incorrect material. This may cause shock mounting to become loose and rattle at the upper connection to the cradle.

Inspection should be performed at the next regularly scheduled maintenance: If the upper end of the shock can be rattled by hand replacement of hardware is required.
