JTB00423NAS2

TECHNICAL BULLETIN

303-00

Accessory Drive Belt Idler Pulley 'Humming' Noise

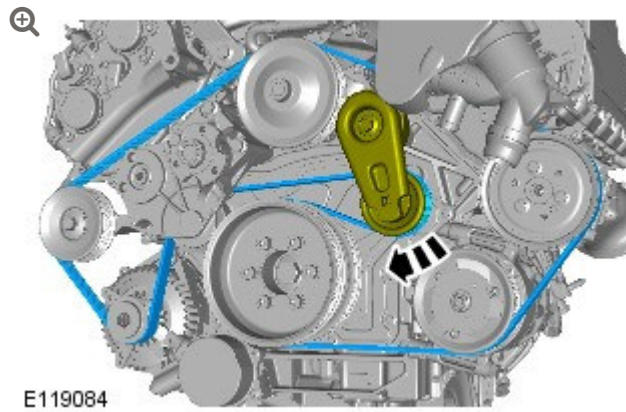
2

Note the fitted position of the accessory drive belt.

Remove the accessory drive belt from the idler pulley.
