TECHNICAL BULLETIN

K430NAS1

Service Action: Roof Opening Panel Air Deflector Springs Displaced

F-PACE (X761)

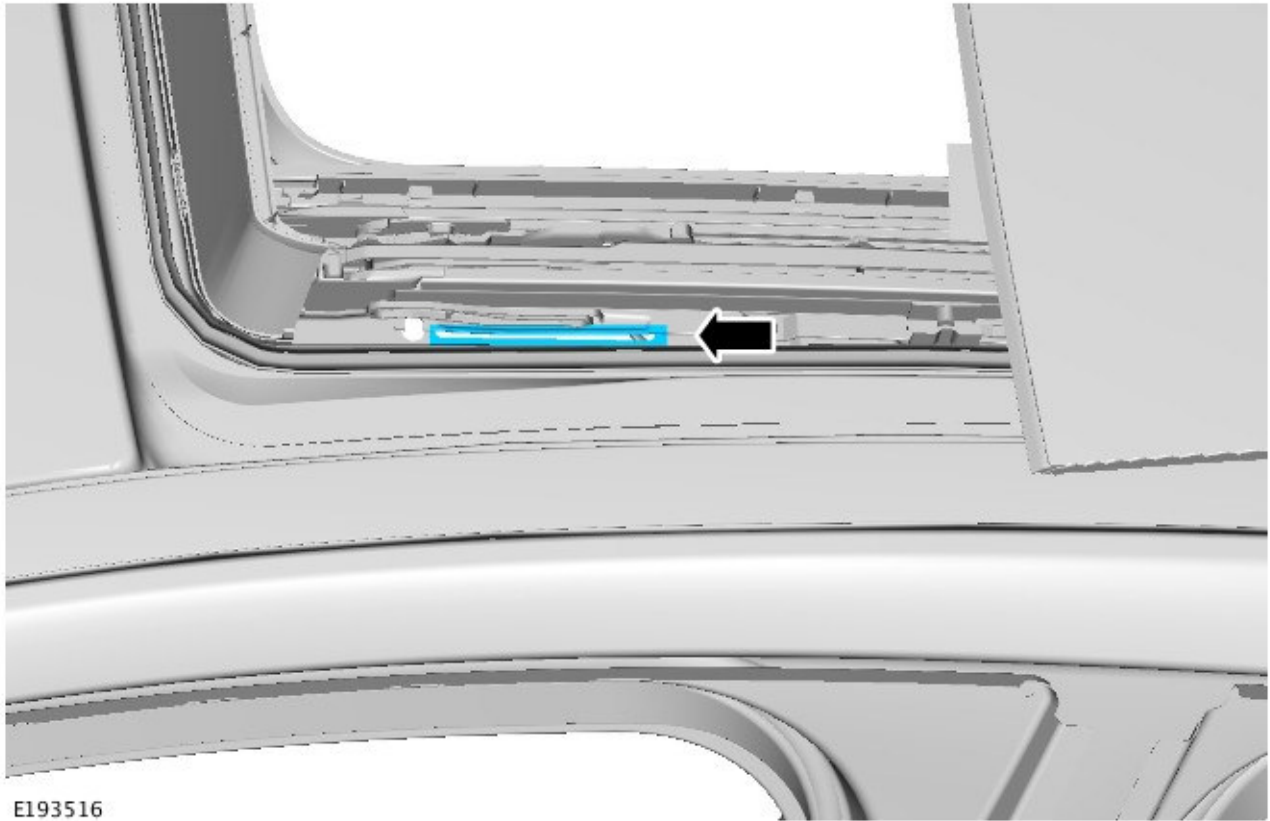
Locate the area shown.

5. Cut and discard 20 mm from the rubber seal.
