TECHNICAL BULLETIN
JTB00480NAS2
01 NOV 2016

SECTION: 303-01

Intake Camshaft Variable Cam Timing Actuator - Component Failure

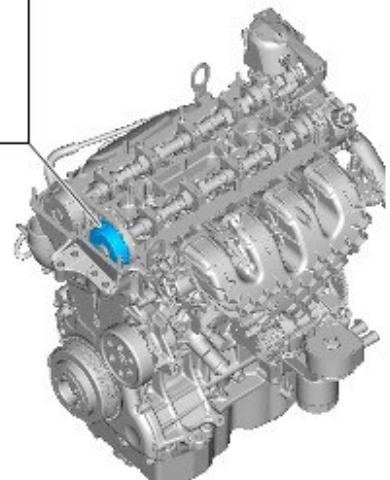
E187366

1. Intake camshaft Variable Camshaft Timing (VCT) actuator location

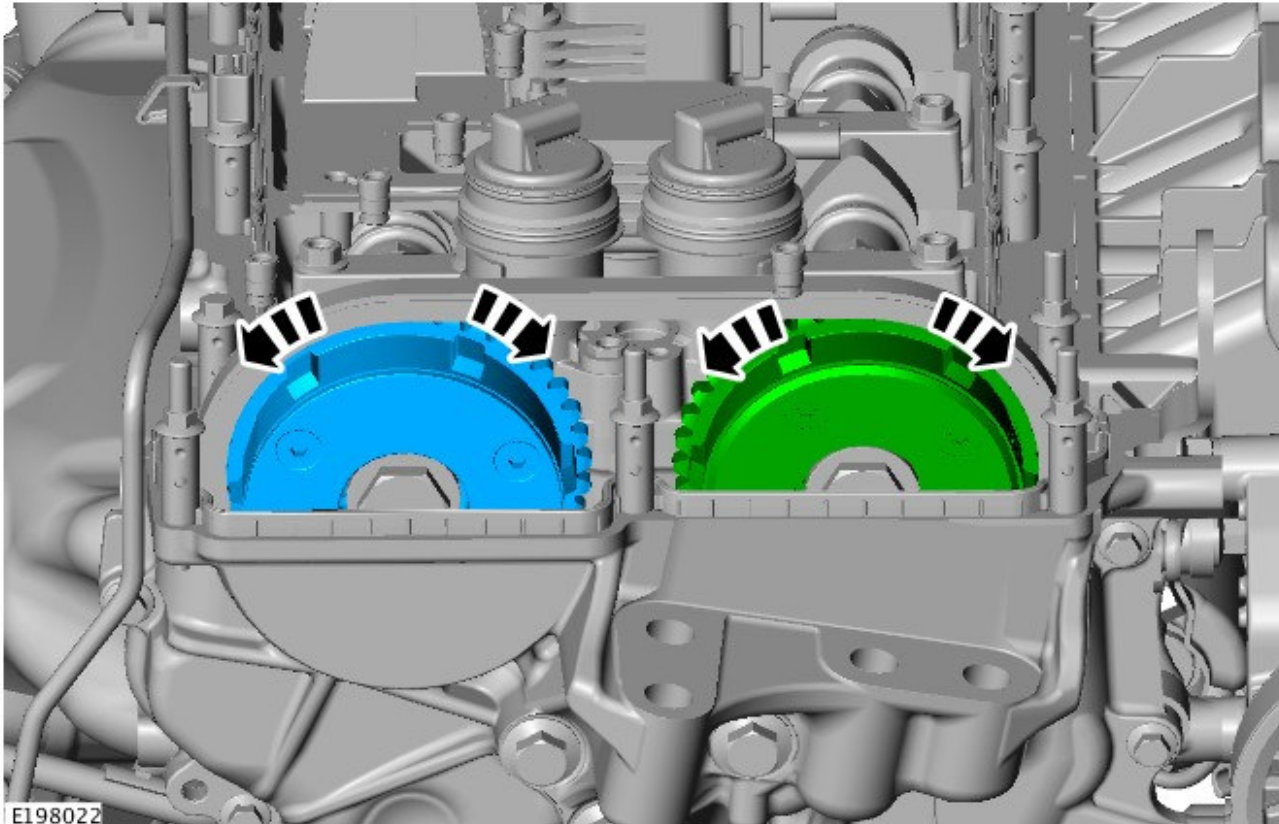
The exhaust camshaft Variable Camshaft Timing (VCT) actuator unit (shown in blue) has restricted movement when turned. The intake camshaft VCT unit (shown in green) has a less restricted movement when turned.

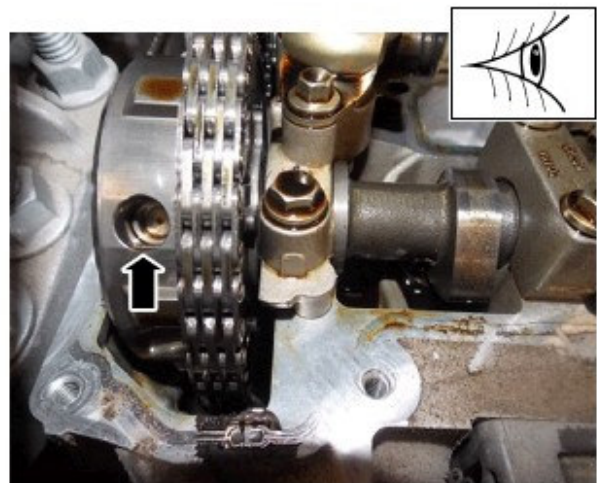
1. Remove the camshaft cover (see TOPIX Workshop Manual section 303-01A / 303-01B / 303-01F: - GTDi 2.0L Petrol/GTDi 2.0L Petrol - Valve Cover).
2. Inspect the Variable Camshaft Timing (VCT) actuator.
 - If the VCT actuator is noisy but the 'stopper' is in place, go to Step 3.
 - If the 'stopper' has become detached from the VCT actuator, go to Step 4.

4. Renew the intake camshaft VCT actuator (see TOPIx Workshop Manual section 303-01A / 303-01B / 303-01F: Engine - GTDi 2.0L Petrol - Variable Camshaft Timing Actuator).

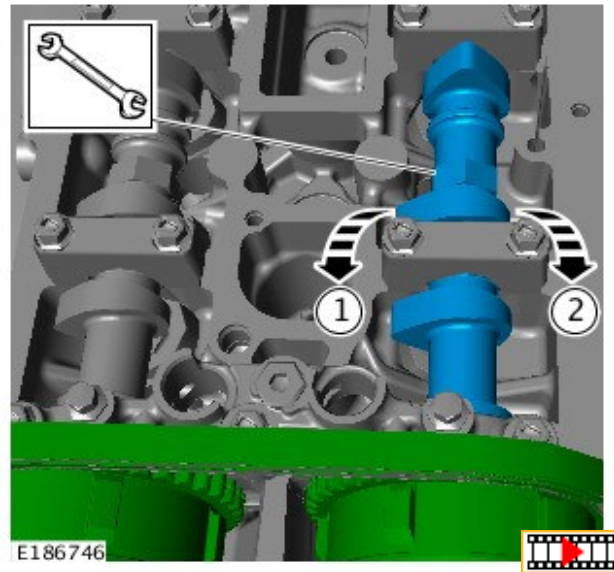
3.

Fully rotate the camshaft anti-clockwise (1) and then attempt to rotate the camshaft clockwise (2).

- If the camshaft rotates freely in both directions, the VCT actuator is NOT functioning correctly; go to Step 4.
- If no clockwise movement was possible without also rotating the engine, the VCT actuator is functioning correctly.
 - Reverse the removal procedure.
