TECHNICAL BULLETIN
JTB00518NAS2
14 NOV 2016

SECTION: 303-03

Engine Coolant Expansion Tank Leak

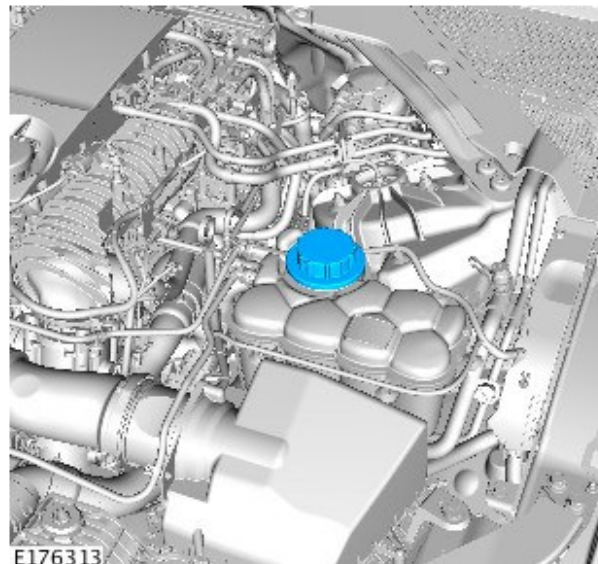
1. Remove the engine coolant expansion tank pressure cap.

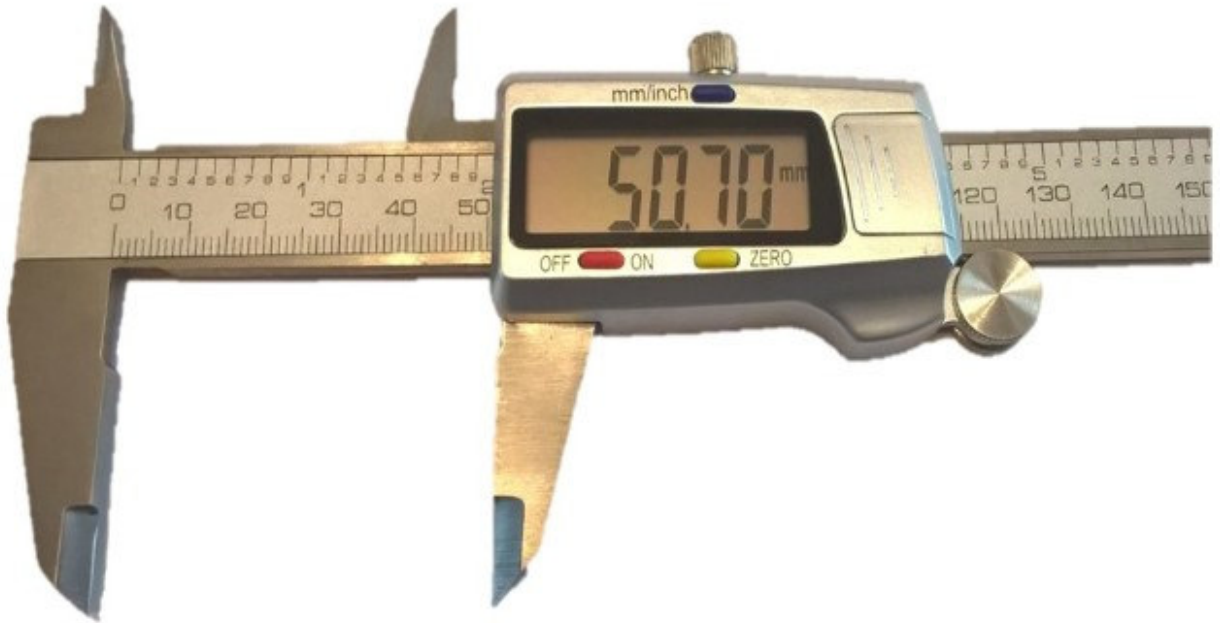
E196112

2. Set a vernier caliper to 50.70mm.

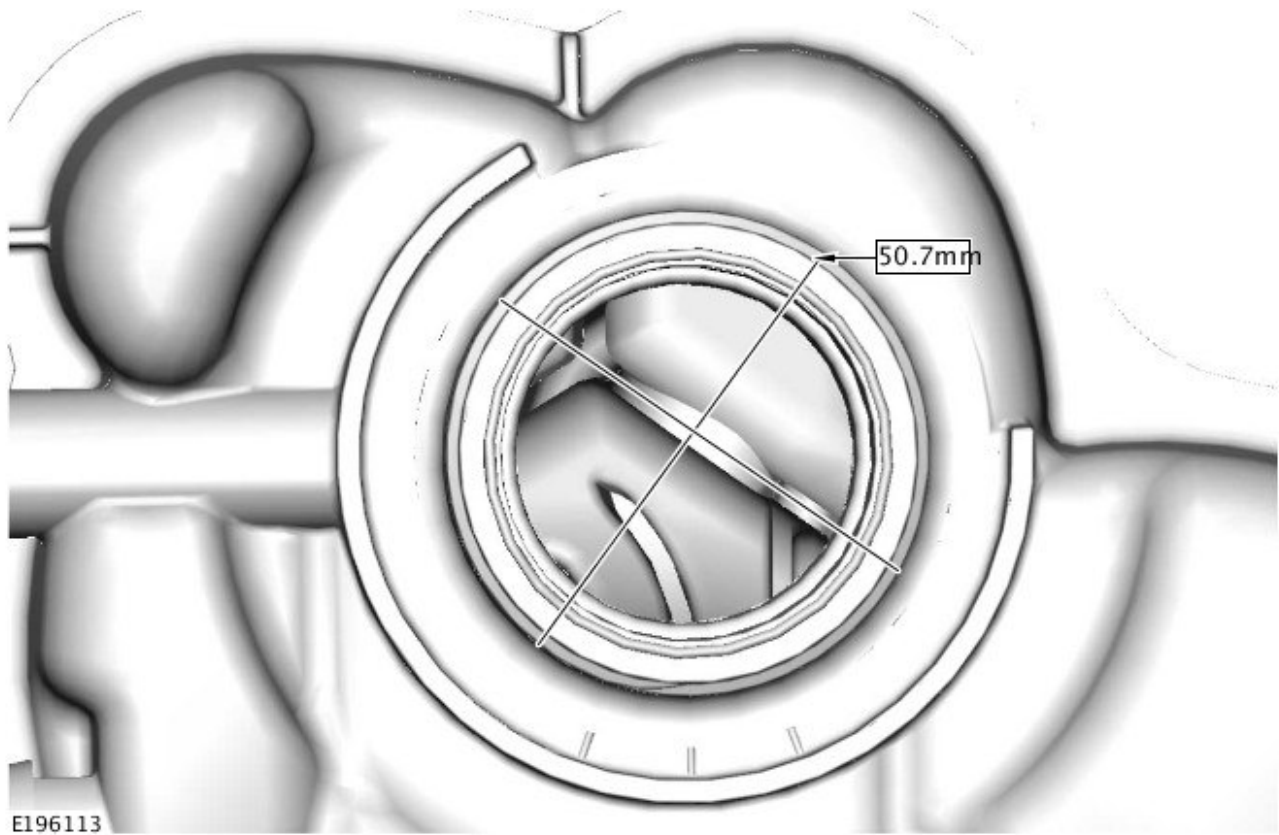
3. Check the dimensions of the engine coolant expansion tank threaded neck in the two positions shown.

- If the dimensions across the centerline neck are less than 50.70mm, go to Step 5.
- If the dimensions across the centerline of the neck are 50.70mm or greater, go to Step 4.

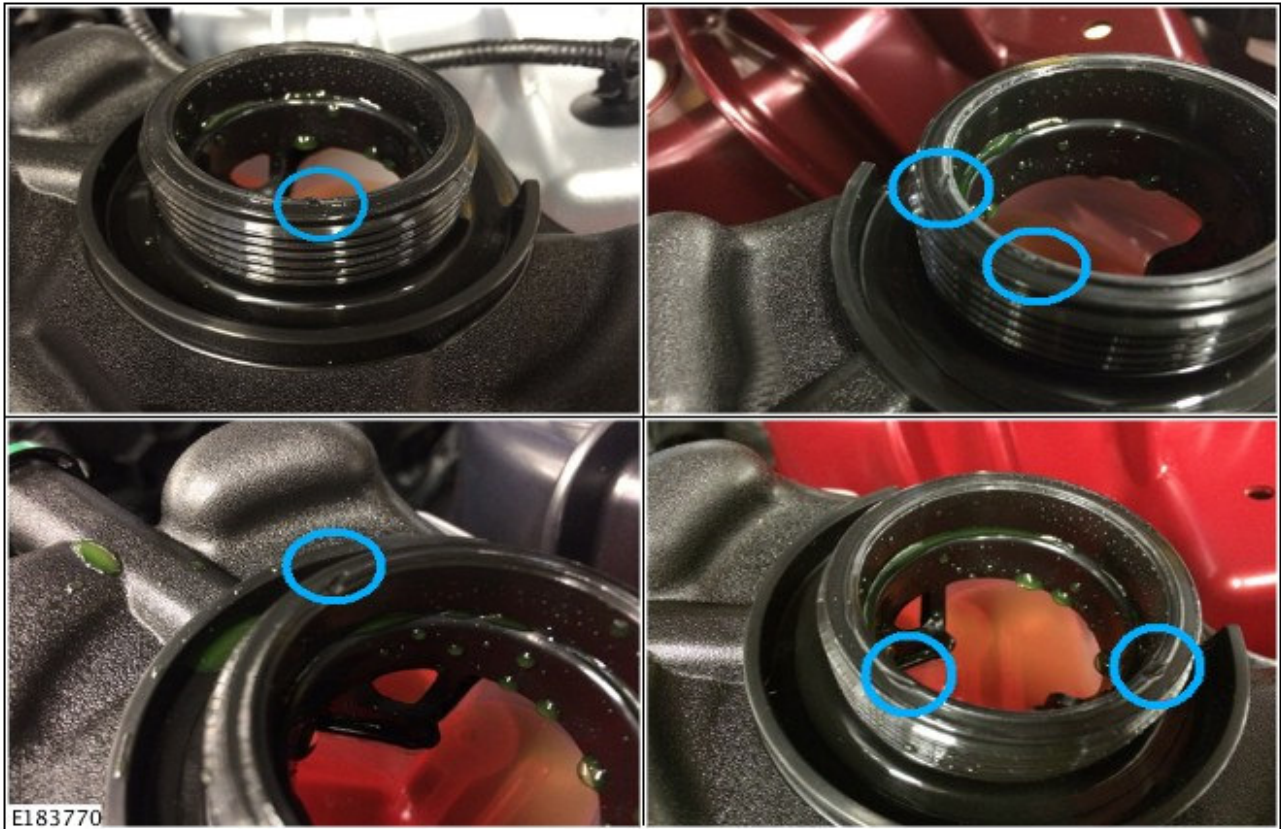
4. Visually inspect the sealing bead on the engine coolant expansion tank neck to check for damage.

- If the sealing bead is damaged, go to Step 5.
- If no damage is found:
 - Install a new engine coolant expansion tank pressure cap.
 - Top up the engine coolant to the MAX level mark.
 - Run the engine up to normal operating temperature, allowing the electric cooling fan to operate at least once without problem before releasing the vehicle.
 - Switch the engine OFF.

5. Install a new engine coolant expansion tank and a new coolant pressure cap (see TOPIx Workshop Manual section 303-03: Engine Cooling - Engine Coolant Expansion Tank).
6. Run the engine up to normal operating temperature, allowing the electric cooling fan to operate at least once without problem before releasing the vehicle.
7. If engine coolant loss continues and/or an engine overheat message is displayed on the Instrument Cluster following completion of this Technical Bulletin, further diagnosis and repair will be necessary (see TOPIx Workshop Manual section 303-03: Engine Cooling - Cooling System Draining, Filling and Bleeding). To be performed as a separate claim.
