Technical Service Bulletin

Subject: AUTO A/C BLOWS WARM AIR	Bulletin No.: 07-003/17
	Last Issued: 03/24/2017

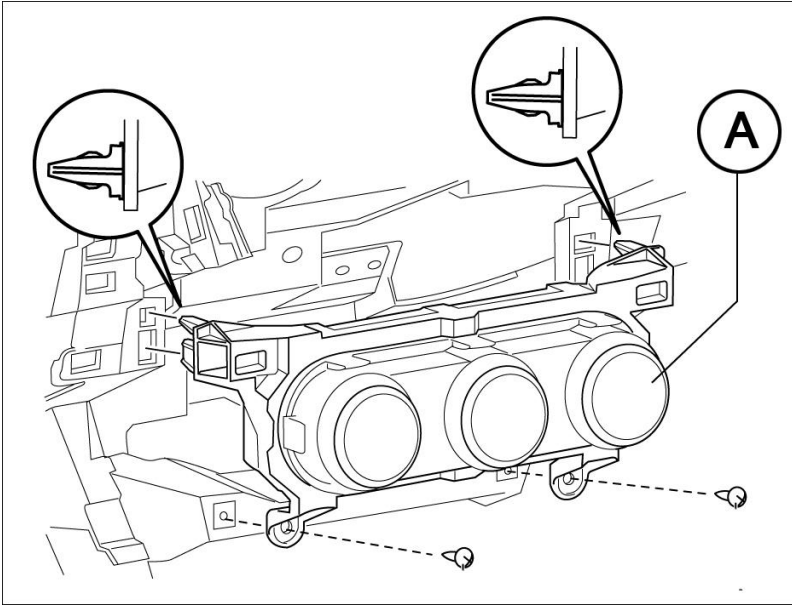
Some customers may complain that it is difficult to adjust the cabin temperature using the auto A/C. This may be more noticeable when the outside temperature is approximately 50 degrees Fahrenheit (10 Celsius).

The climate control unit logic has been changed to correct this concern.

2. Replace the climate control unit (A). Refer to **MGSS**online:

- CX-3 - CLIMATE CONTROL UNIT REMOVAL/INSTALLATION [FULL-AUTO AIR CONDITIONER].
- Mazda2- CLIMATE CONTROL UNIT REMOVAL/INSTALLATION [FULL-AUTO AIR CONDITIONER].
