Subject: 2009-2013 MAZDA6 - WINDSHIELD WIPERS INOPERATIVE AT TIMES DUE TO MISSING WIPER MOTOR COVER	M-Tips No.: MT-011/17
	Last Issued: 06/08/2017

2009-2013 Mazda6

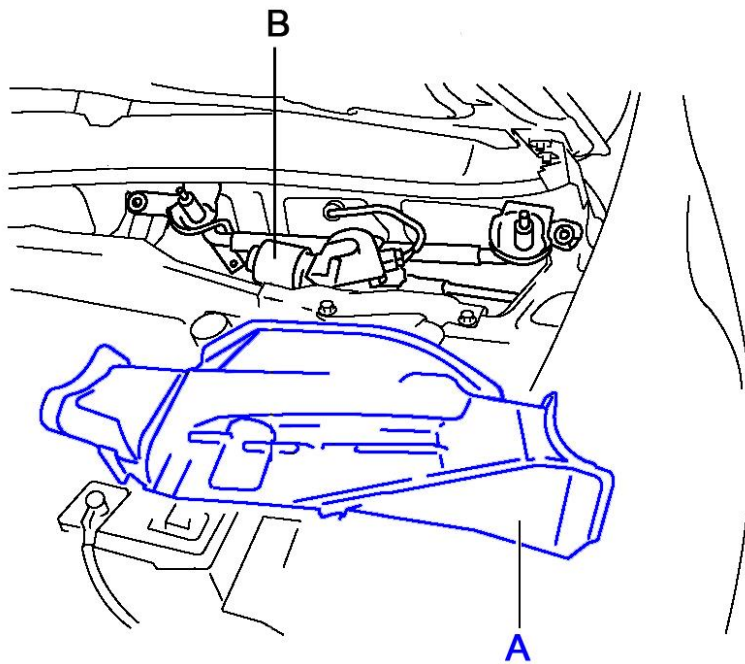
Some vehicles may experience intermittent non-operation of the windshield wipers. The wiper motor cover (A) may have been discarded during a previous repair. The missing wiper motor cover (A) may allow elements to contaminate the wiper motor (B) and cause an intermittent open circuit.

If the diagnosis requires a wiper motor replacement to correct the customers concern, install the wiper motor cover if it is missing.

NOTE: Installation of a new wiper motor with a missing wiper motor cover may create a customer come-back situation.
