SERVICE BULLETIN

APPLICABILITY: All Models Equipped with CVT Transmissions

NUMBER: 16-102-16

SUBJECT: DTC P0841 Diagnostics

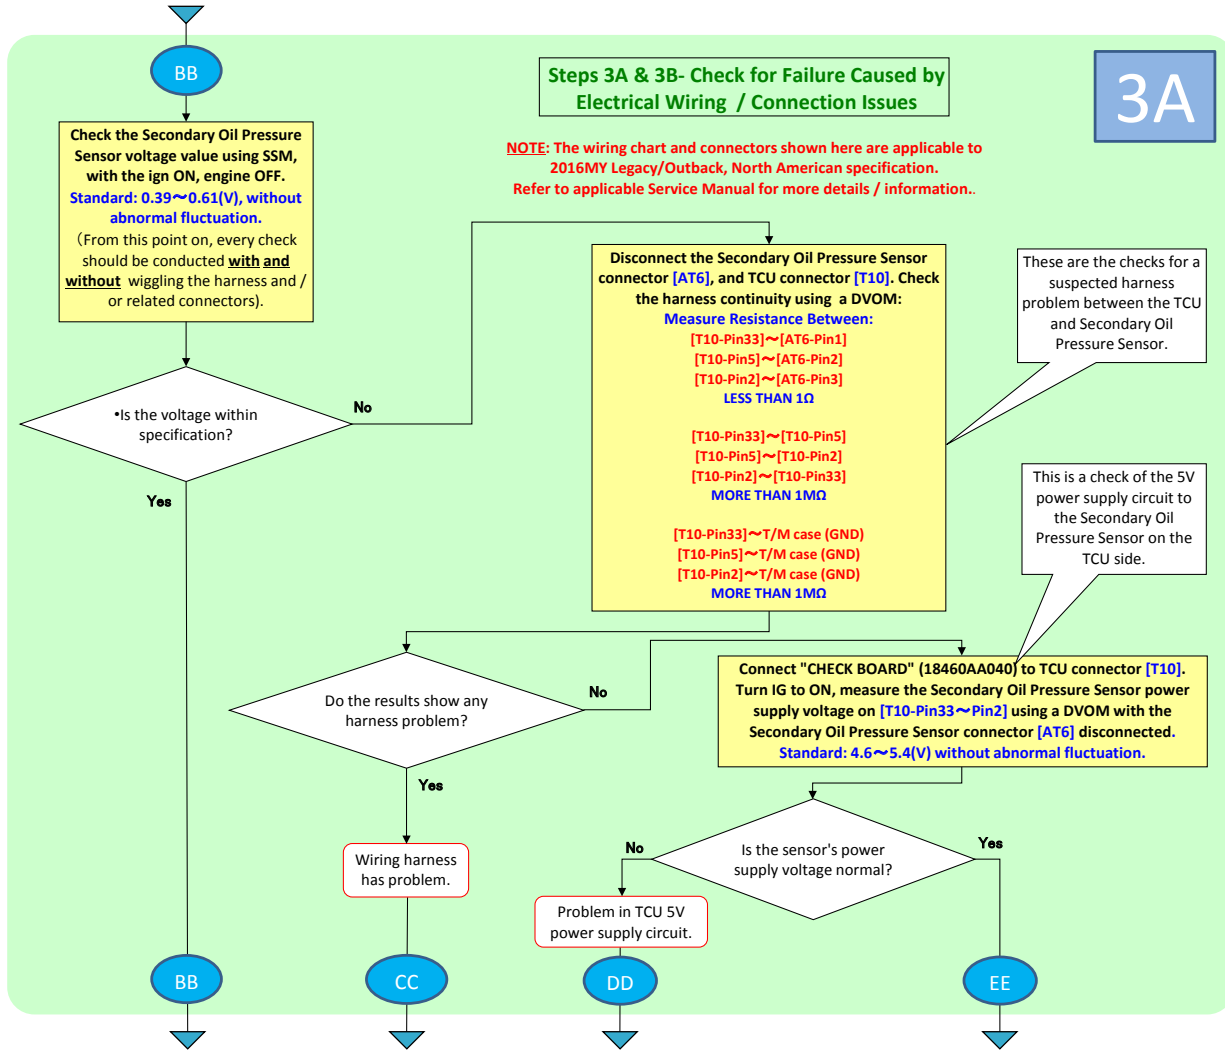
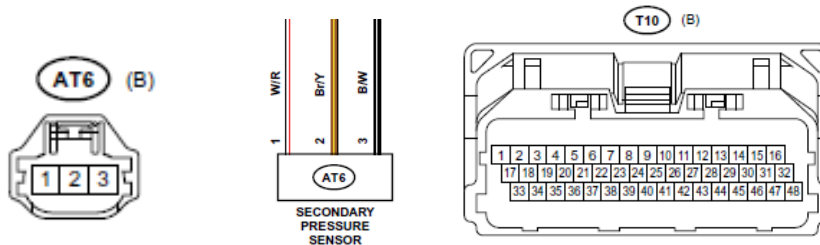
STEP 3A:

<p style="font-size: 0.8em;">ST18460AA040</p>	18460AA040	CHECK BOARD	Used for measuring the TCM terminal voltage.
---	------------	-------------	--

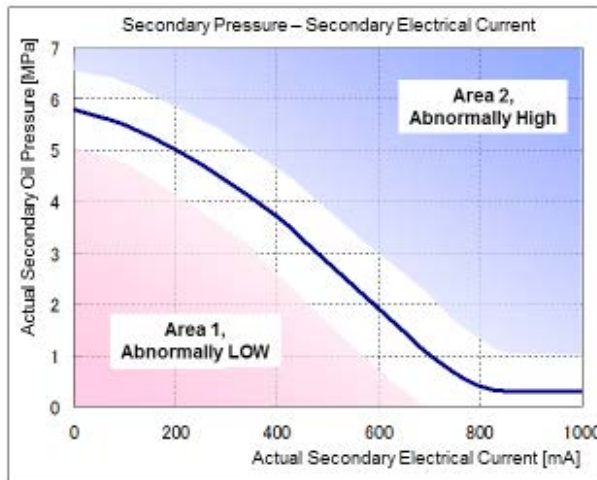
How To Identify the Condition Causing DTC P0841 to Set by Reviewing the Stored FFD

The condition causing P0841 is either:

- The Secondary Oil Pressure is abnormally low (lack of necessary pressure)
- The Secondary Oil Pressure is abnormally high (excess pressure occurs as compared to necessary pressure).

Check the Actual Secondary electrical current [mA] and Actual Secondary oil pressure [MPa] stored in the FFD then determine if P0841 has set because of:

- abnormally low
- abnormally high Secondary Oil pressure.

TIP: Consider performing the pressure testing using a mechanical pressure gauge **BEFORE** electrical testing and compare the test results (between the gauge and SM4 displayed values). Both test results should be very close. If there is a significant discrepancy between them (e.g. the (known good) gauge results are significantly higher than the SM4-supplied values), the pressure sensor would be suspect.

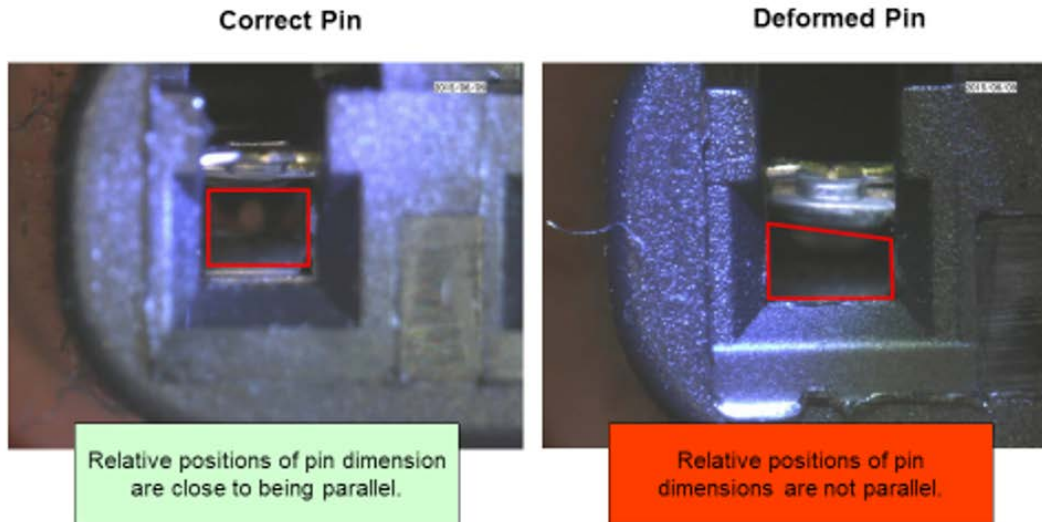
Example of a Deformed Pin Terminal:

(1) Inspect for any abnormalities with the pins like: deformation, scratches, discoloration or evidence of any foreign materials inside them or the connectors.
