SERVICE BULLETIN

APPLICABILITY: 2015-2016 Legacy and Outback Models
 2012-2016 Impreza and XV Crosstrek Models
 2014-2017 Forester Models
 2015-2016 WRX and STI Models

NUMBER: 12-203-16
DATE: 07/14/16

SUBJECT: Squeaking Sound from Front Seat Buckle

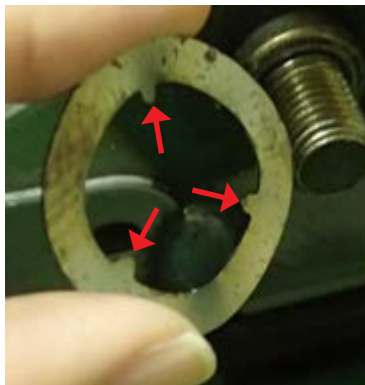
OLD Wave Washer

This bulletin provides a procedure to address customer concerns of a squeaking sound originating from where the front seat belt buckle assembly attaches to the seat frame. A design change was made to the wave washer used at the attachment point to eliminate the sound. The sound can be heard when moving the buckle assembly side to side.

The 3 “tang” seen on the inside of the **OLD** wave washer have been deleted. The inside diameter of the **NEW** wave washer has been decreased and a small felt added to allow the washer to turn smoother with the buckle and have a better fit on the shoulder portion of the retaining bolt.
