Second Row Seat Squeak

Service Category Vehicle Interior

Section Seat

YEAR(S)	MODEL(S)	ADDITIONAL INFORMATION
2010 – 2015	4Runner

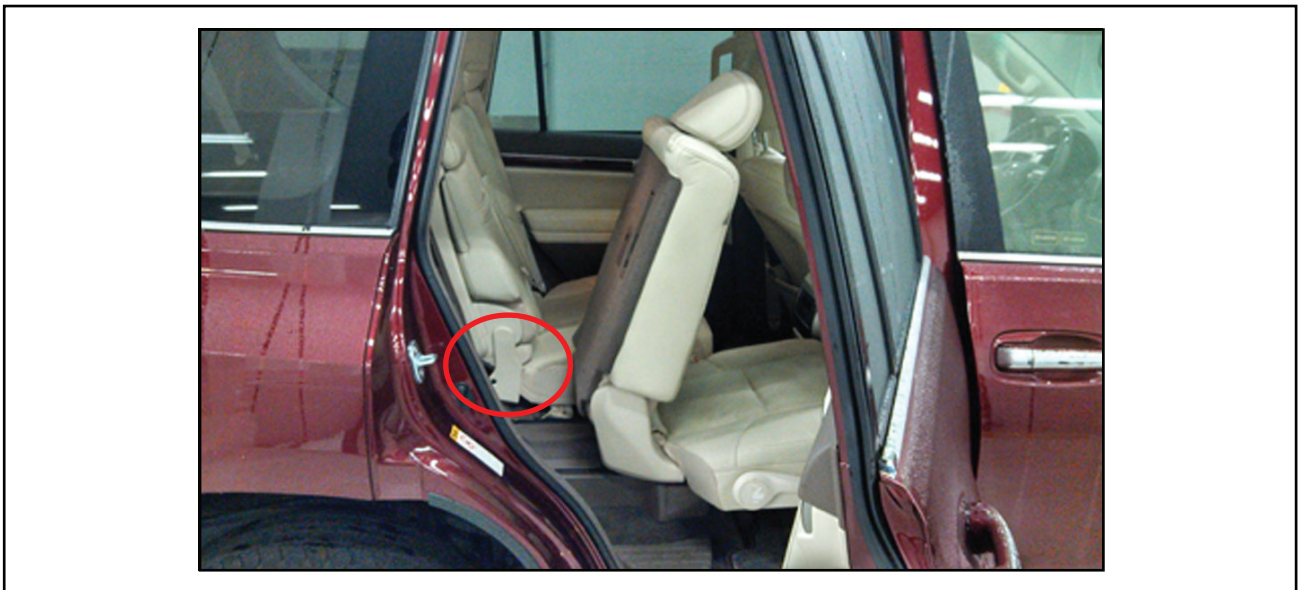
Figure 1.

Some 2010 – 2015 model year 4Runner vehicles may exhibit a squeak noise coming from the second row seats when driving over uneven terrain. The bracket for the inside hinge of the 60% second row seat may rub the seat frame. Follow the procedure outlined below to address this condition.

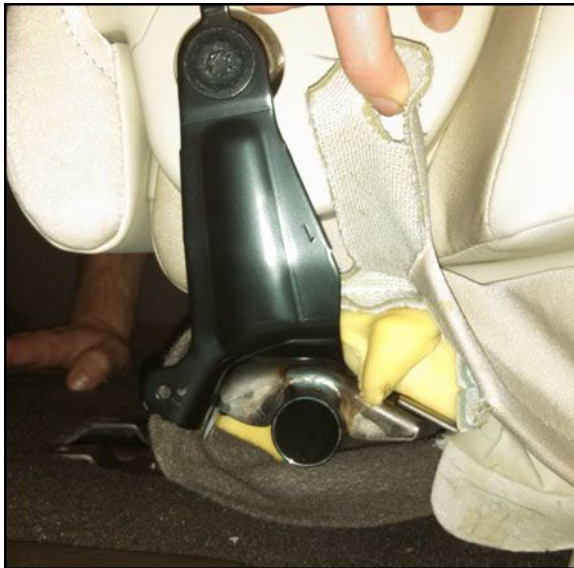
Figure 3. Approximate Vantage Point (Reposition Foam to Access View)

3. Confirm that a noise is being generated by two surfaces rubbing, as shown below.
