# LH Rocker Panel Pop/Creak Noise

YEAR(S)	MODEL(S)	ADDITIONAL INFORMATION
2014 – 2015	Avalon, Avalon HV

Some 2014 – 2015 model year Avalon and Avalon HV vehicles may exhibit a condition where there is a pop/creak type noise from the LH rocker panel/bottom of the driver's door opening area. This is caused by two body panels contacting one another within the rocker panel structure. Use the following Repair Procedure to address this condition.

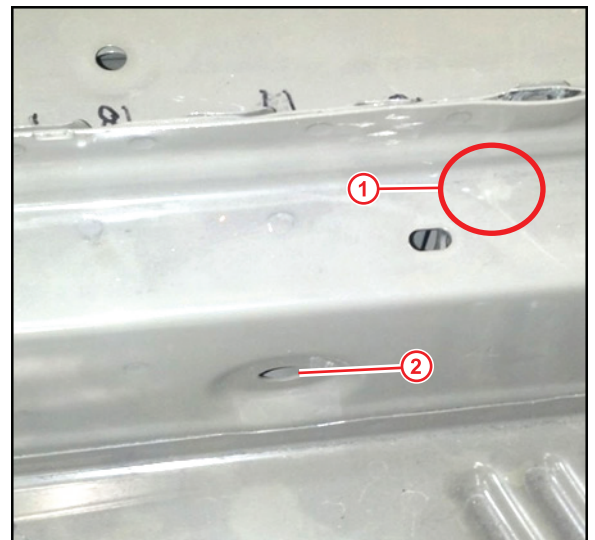
**Figure 3. Contact Point No. 1**

<b>1</b>	Contact Point No. 1
<b>2</b>	Access Hole

- A. Using a borescope, navigate into the rocker panel through the access hole (from step 1E) towards the contact point No. 1.

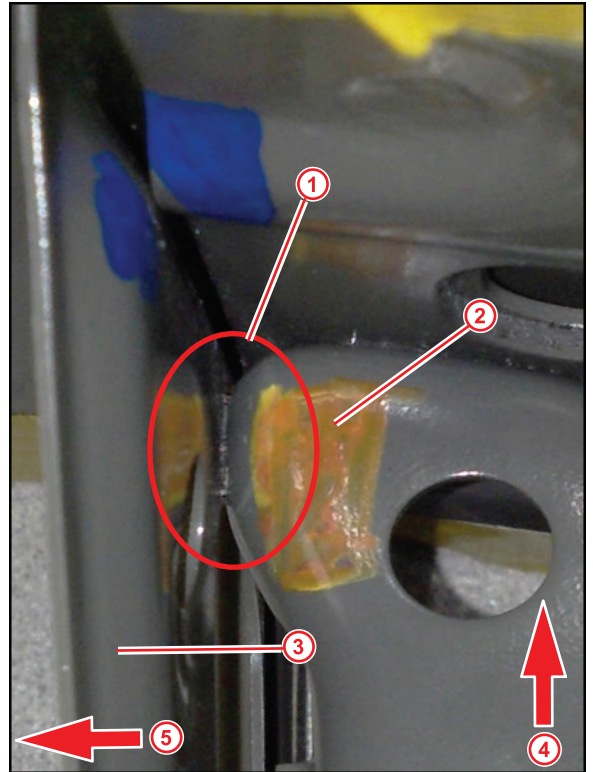
**Figure 4.**

- B. Observe through the borescope if any part of the A-pillar reinforcement is contacting the step panel reinforcement at contact point No. 1.

1	Contact Point No. 1
2	Step Panel Reinforcement
3	A-pillar Reinforcement
4	Up
5	Left of the Vehicle

- C. If contact is found in step 2B, insert a prybar through the access hole to the position of contact between the A-pillar reinforcement and the step panel reinforcement.

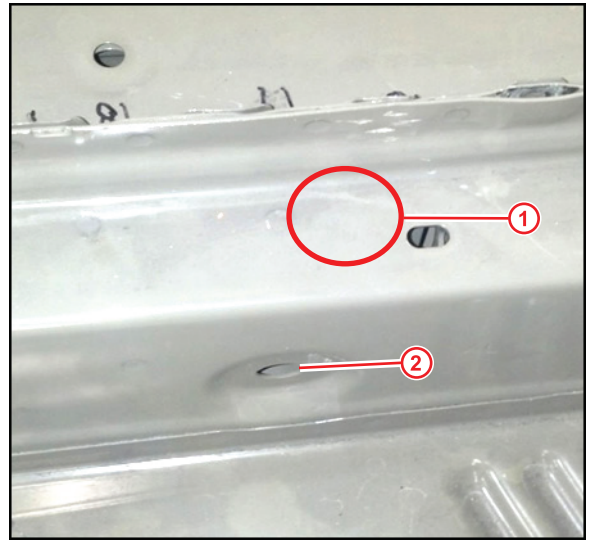
**Figure 7. Contact Point No. 2**

<b>1</b>	<b>Contact Point No. 2</b>
<b>2</b>	<b>Access Hole</b>

3. Confirm and repair contact point No. 2.
  - A. Using a borescope, navigate into the rocker panel through the access hole (from step 1E) towards contact point No. 2.

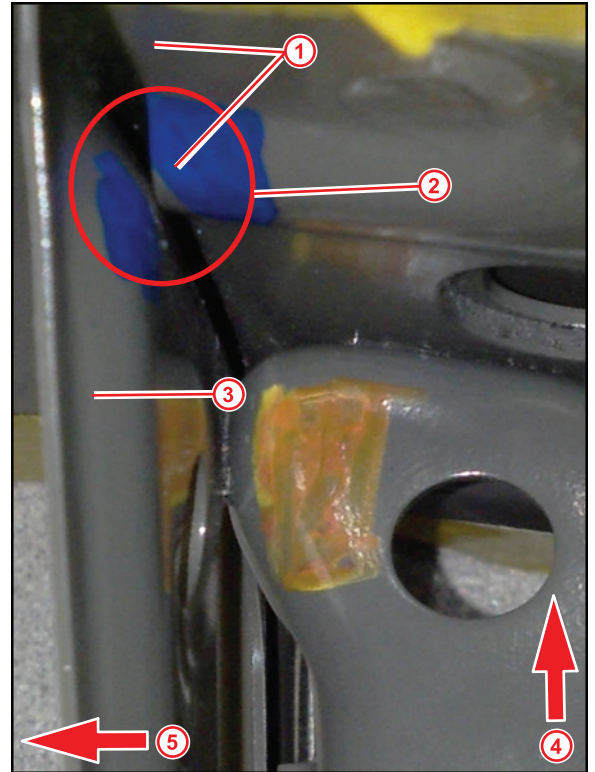
**Figure 8.**

- B. Using the borescope, observe if any part of the A-pillar reinforcement is contacting the front floor under reinforcement bracket at contact point No. 2.

1	Front Floor Under Reinforcement Bracket
2	Contact Point No. 2
3	A-pillar Reinforcement
4	Up
5	Left of the Vehicle

- C. If contact is found in step 3A, insert a pry bar through the access hole and use the tip of the pry bar to locate the contact point between the A-pillar reinforcement and the front floor under reinforcement bracket.
