Reduced Air Flow Through Seat

Service Category Vehicle Interior

Section Seat

Some 2013 – 2014 model year ES 300h and ES 350 vehicles may exhibit a condition where the seat cooler operation is less than customer expectation. This is due to the air duct collapsing when there is weight in the seat, thus restricting air flow through the air duct. Use the following bulletin to address this condition.

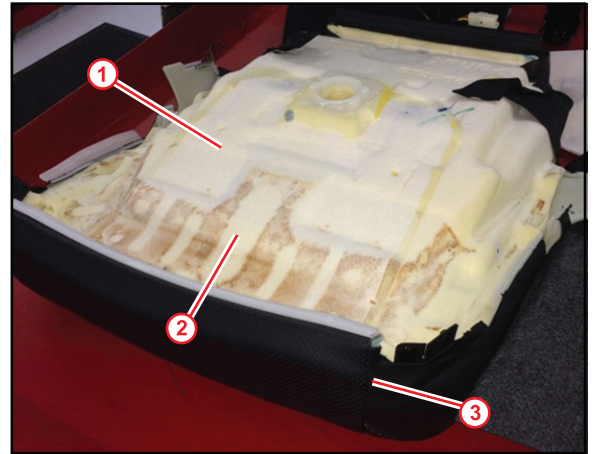
Figure 1.

1	Sub-pad
2	Main Pad
3	Seat Cover

3. Disassemble front seat assembly per Repair Manual instruction in order to access bottom of seat cushion pad.

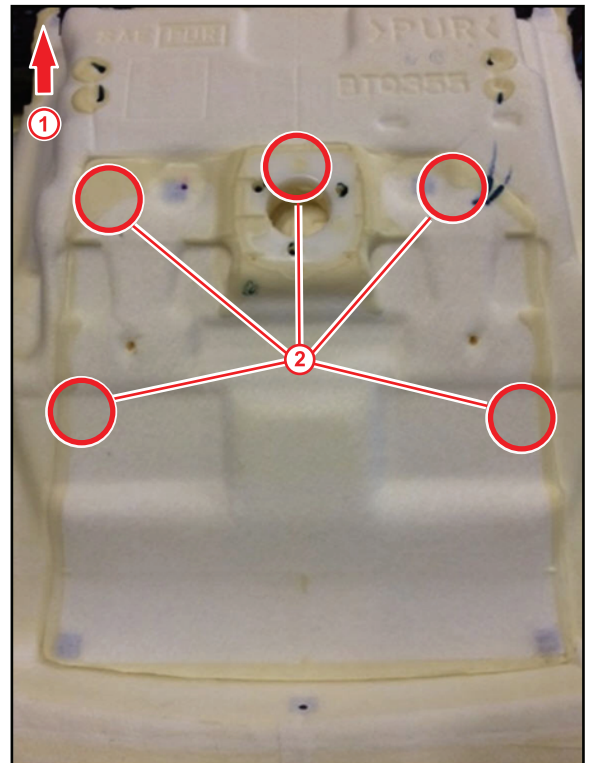
1	Rear of Sub-pad
2	Glue Locations

4. Gently separate rear portion of sub-pad from main pad assembly by separating glue spots noted in Figure 2.

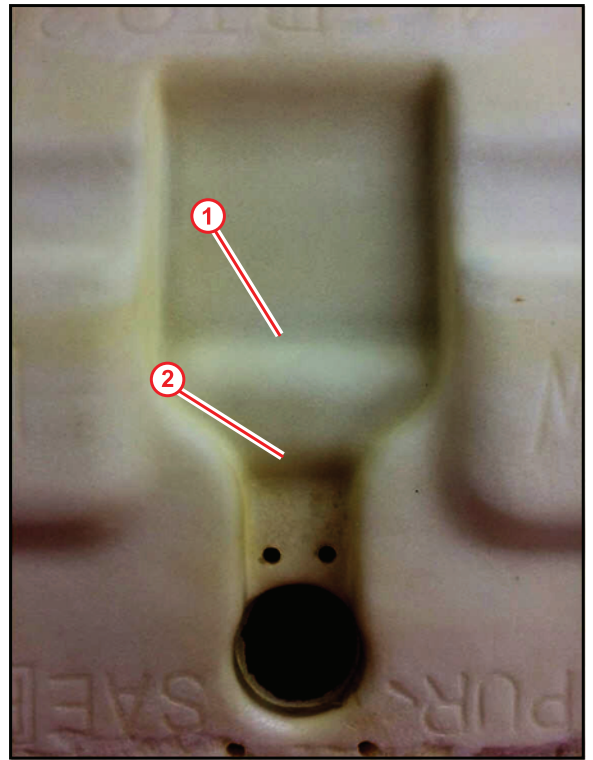
Figure 5.

1	Indented Portion of Sub-pad Cutout
2	Ridge

6. Adhere duct to sub-pad.

- A. Align curved shape of duct profile to indented portion of sub-pad cutout (narrow end of duct will align with ridge of seat sub-pad).

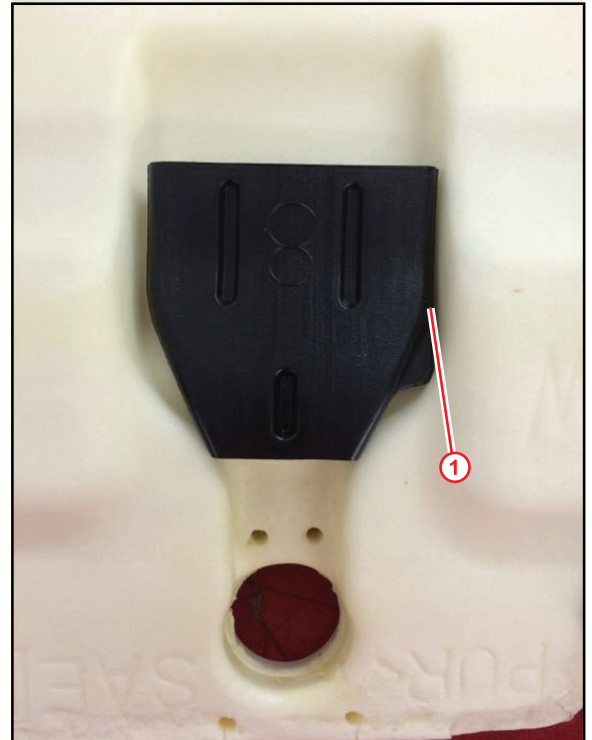
Figure 6.

1 Align Sides

- B. Align side edges of duct with sides of sub-pad cutout.

Ensure duct is positioned such that ends will NOT be blocked once weight is added to seat.
