O2 Sensor Readiness Monitor Does Not Complete

Service Category Engine/Hybrid System

Section Emission Control

YEAR(S)	MODEL(S)	ADDITIONAL INFORMATION
2007	Highlander HV

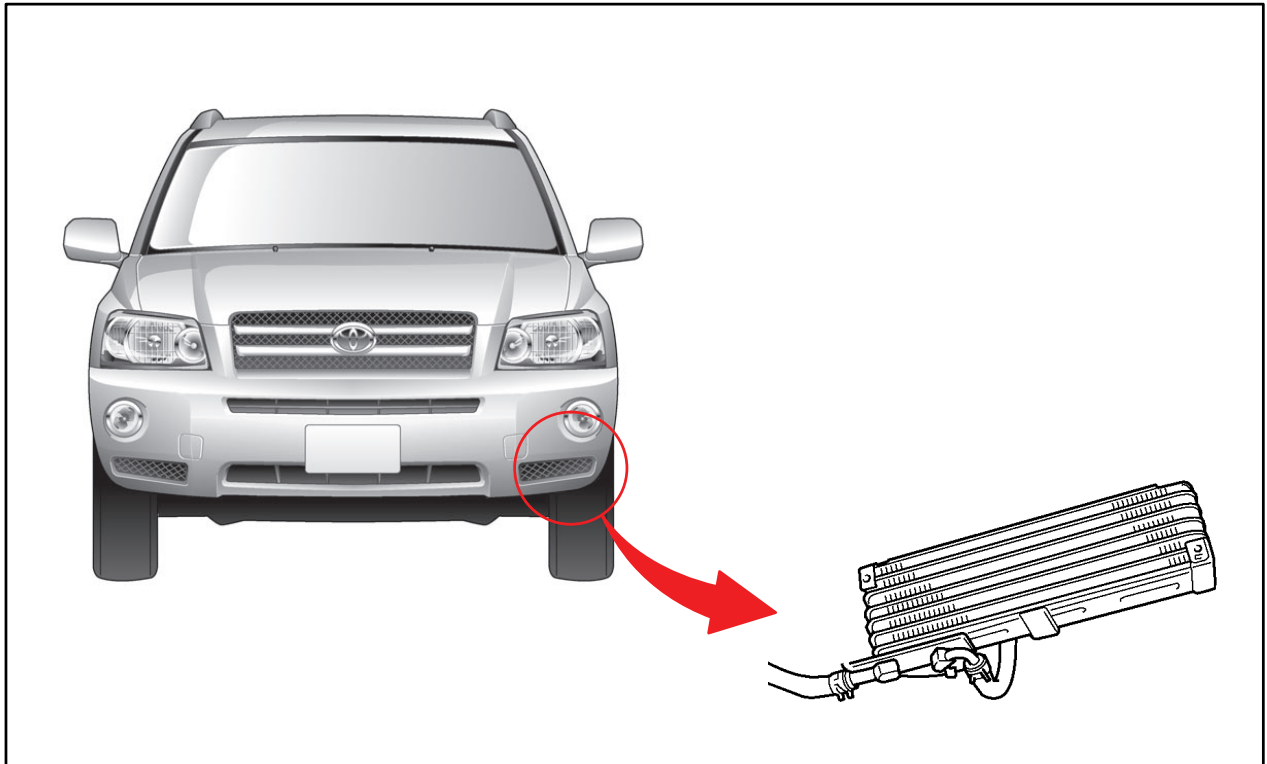
Figure 1. Location of Transaxle Oil Cooler (on Equipped Vehicles)

There are different calibration files for vehicles with and without transaxle oil coolers. In order to determine the configuration of your vehicle, shine a flashlight into the left front bumper cover vent. If the vehicle is equipped with a cooler, it will be easily visible.

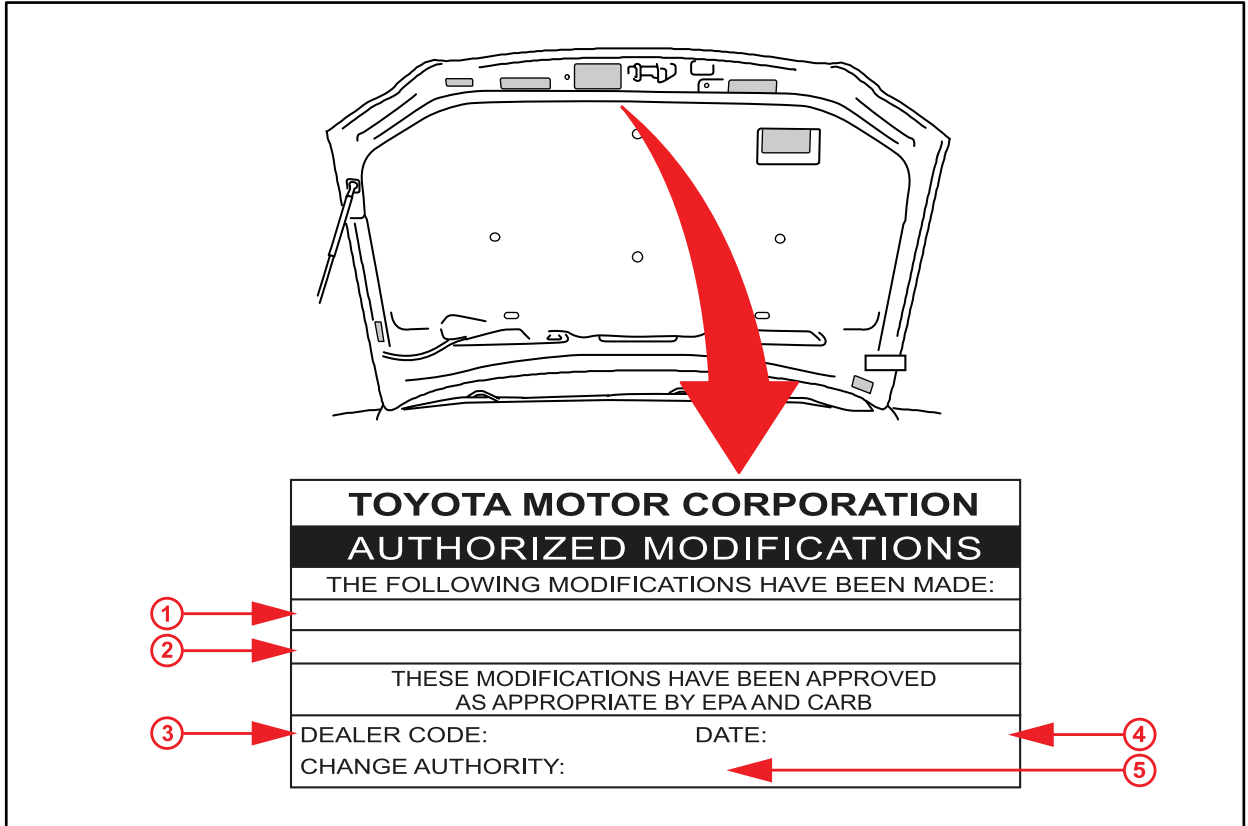
Figure 2. Location of Authorized Modifications Label on 2007 Highlander HV

2. Check for the Authorized Modifications Label affixed to the vehicle in the location shown in Figure 2. Confirm if the HV ECU and ECM (PCM) calibrations have been updated. If the calibration IDs are NOT the latest calibrations — go to step 2.

1	Replacement ECM (PCM) Part Number (i.e., 89981-48262)
2	New Calibration ID(s) (i.e., 899834820100)
3	Dealer Code

4	Date Completed
5	This SB Number

- Start the engine and warm it up to normal operating temperature before test driving.
- Test drive the vehicle to confirm proper vehicle operation (and proper laser cruise control operation, if equipped).
- Confirm that the O2 sensor monitor reads “complete”.
- Install the Authorized Modifications Label.
 - Using a permanent marker, enter the following information on the label:
 - ECM part number [*Refer to the **Parts Information** section for the **NEW PART NUMBER***]
 - Calibration ID(s) [*Refer to the **Calibration Information** section for the **NEW CALIBRATION ID***]
 - Dealer Code
 - Repair Date
 - Change Authority [***This bulletin number***]
 - Affix the Authorized Modifications Label to the vehicle at the location shown in Figure 2. The Authorized Modifications Label is available through the MDC, P/N 00451-00001-LBL.
