Abnormal Entune/Navigation Operation For Display Audio (Non-HDD Type)

Service Category Audio/Visual/Telematics

Section Navigation/Multi Info Display

Market USA

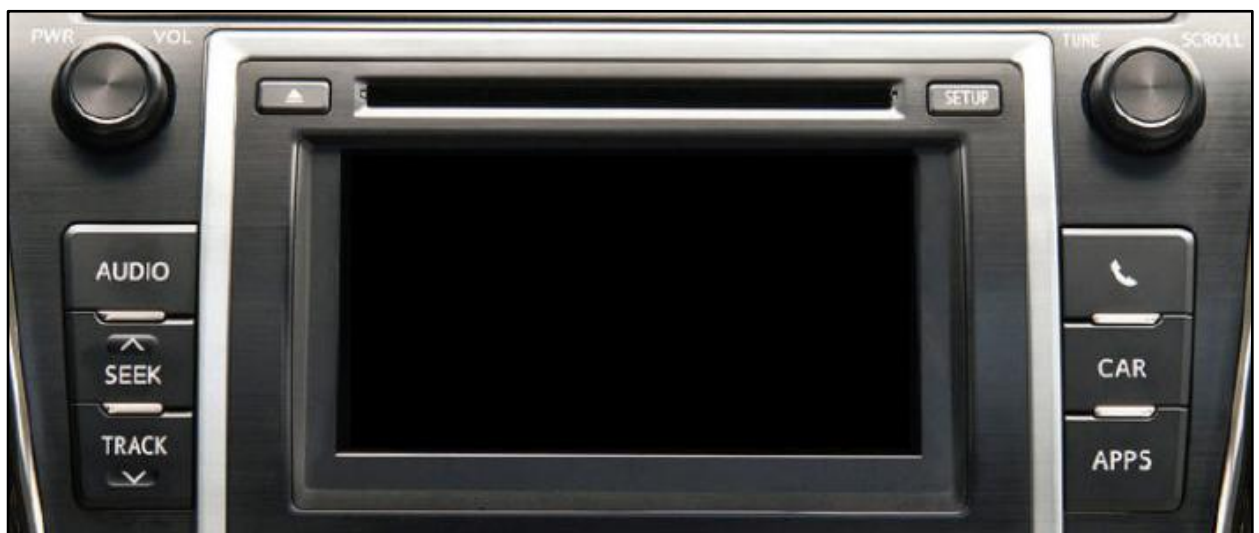
Figure 1.

- Non-HDD Type Navigation units have a CD slot visible on the front of the radio.
- HDD Type Navigation units have a tilt-open navigation screen and CD slot behind the screen.

1. Confirm that 1 or more of the conditions listed in the Introduction for all software variants are present.
