Service Category Vehicle Exterior

Section	Door/Hatch	Market USA	Toyota Supports
---------	------------	------------	-----------------

YEAR(S)	MODEL(S)	ADDITIONAL INFORMATION
2014 - 2015	Highlander, Highlander HV	WMI(s): 5TD VDS(s): BCRFH, BKRFH, DCRFH, DKRFH, JCRFH, JKRFH, KKRFH, YKRFH, ZKRFH Plant Code(s): S

Introduction

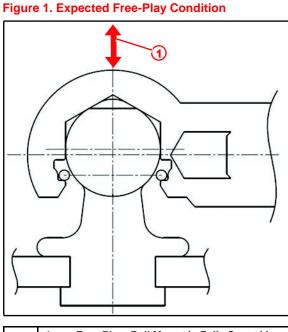
Figure 2. No Free-Play Condition

6. After installing the NEW Power Back Door actuators, confirm that the ball and socket joints (2 LH and 2 RH) are properly seated, and have approximately 1 mm of free-play as indicated in Figure 1.

- If free-play is present, continue to step 7. •
- If there is NO free-play as shown in Figure 2, the ball mount is NOT fully seated in • the socket.

1 mm Free-Play: Ball Mount is Fully Seated in 1 the Socket

No Free-Play: Ball Mount is Not Fully Seated 2 in the Socket

- If the ball mount is NOT fully seated in the socket mount separation may occur, which may cause damage to the vehicle.
- Attempt to seat the joint by pushing on the actuator near the socket. If free play cannot be achieved, replace the actuator and ball mounts with another NEW service part.
