Service Bulletin

PRELIMINARY INFORMATION

Subject: Poor Engine Performance P0089 P228D P0171 Whine Noise From High Pressure Fuel Pump

Models: 2010-2011 Buick LaCrosse
2011 Buick Regal
2010 - 2011 Chevrolet Equinox
2010-2011 GMC Terrain
Equipped with 4 cyl engine (RPO LAF)

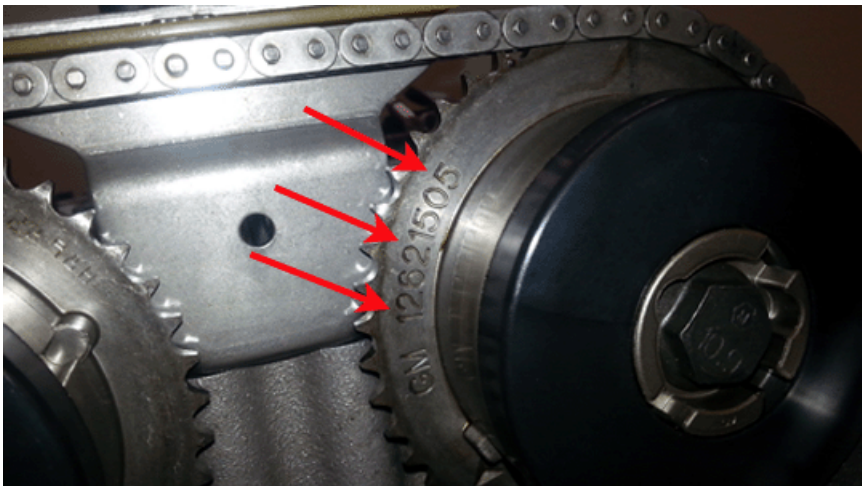
Below is an example of a 2011 intake camshaft actuator part number 12621505 and black in color (plastic cover piece).

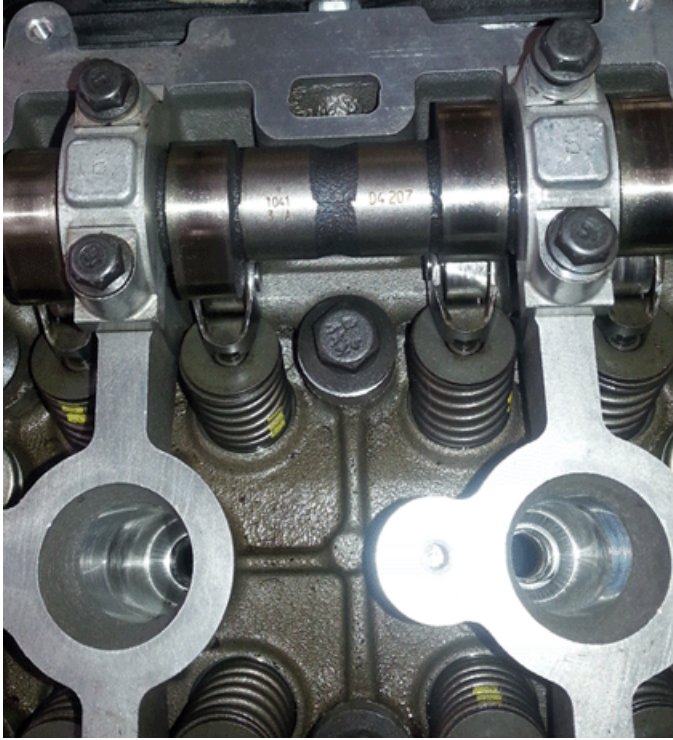
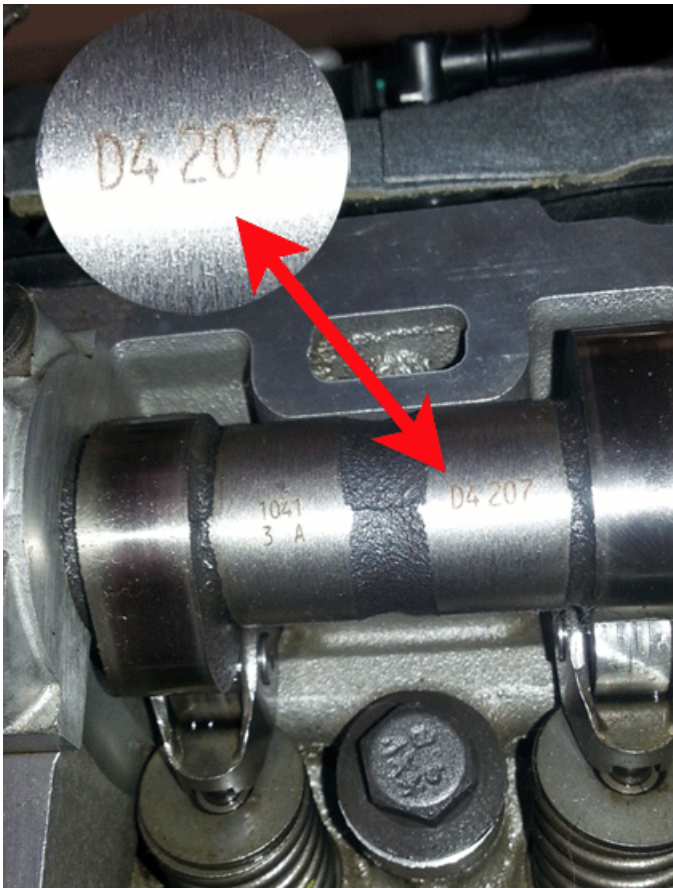
The camshafts can be identified by the last four digits of the part number located on a machined surface between the number 2 and number 3 cylinder camshaft lobes.

Below is an example of a 2011 intake camshaft part number 12634207.
