# Service Bulletin

**Subject:** MIL due to DTC P0128 and/or P0171 and No Engine Performance Concerns

**Models:** 2011 Buick Lacrosse, Regal  
2011 Chevrolet Equinox  
2011 GMC Terrain  
with 2.4L Engine (RPO LAF)

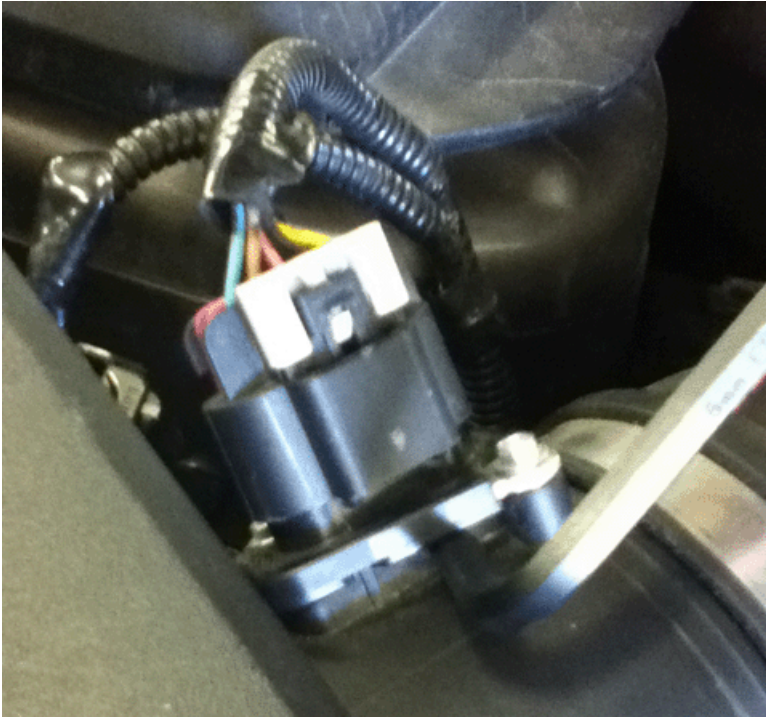
8. For Equinox and Terrain Models Only, also inspect the air cleaner lid to ensure that it is correct by confirming the height of the MAF sensor as shown below. If the correct air cleaner lid is installed, you should be able to place a 6 mm allen wrench/bit between the MAF sensor and air cleaner housing as shown below to feel a slight drag or if you use a 7/32" allen wrench/bit you will feel a small amount of play/clearance. If the incorrect air cleaner lid is installed, it will be obvious when the allen wrench/bit is installed because there will be about an additional 1/8" of clearance present. If an incorrect air cleaner lid is found, replace the air cleaner assembly using the correct part number listed in the parts catalog, re-evaluate the concern, and submit a

**Correct Air Cleaner Lid with a 6 mm Allen Wrench Installed for Reference**

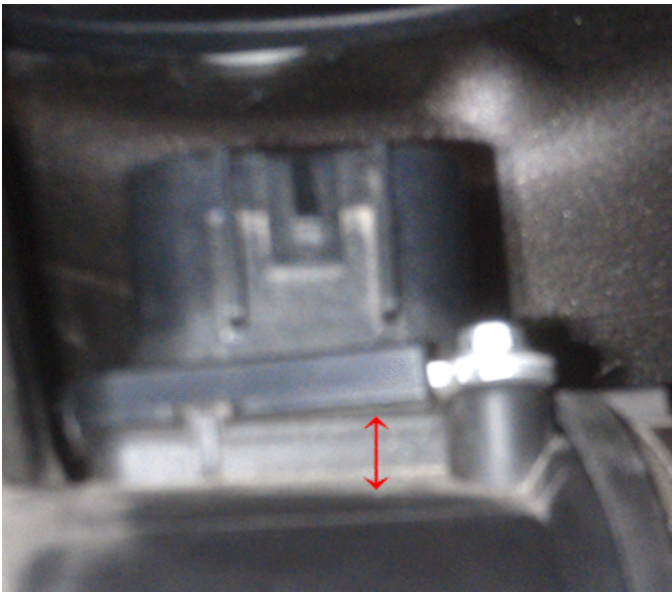
**Correct Air Cleaner Lid**

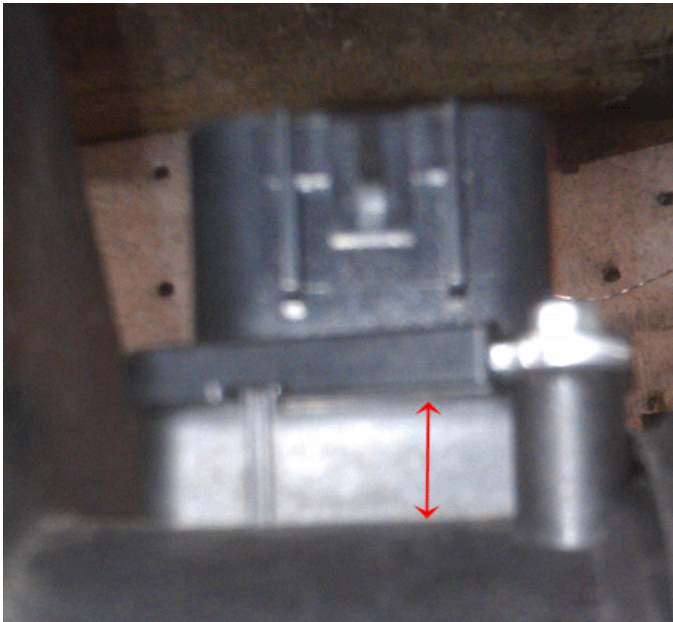
**Incorrect Air Cleaner Lid**

product report with photos by following the latest version of 07-00-89-036.
