# Service Bulletin

Subject: Roof Beacon Inoperative (Switch Disconnected)

Models: 2011-2013 Chevrolet Silverado, Tahoe, Suburban

2011-2013 GMC Sierra, Yukon, Yukon XL With Roof Beacon Light (RPO VYU or TRW)

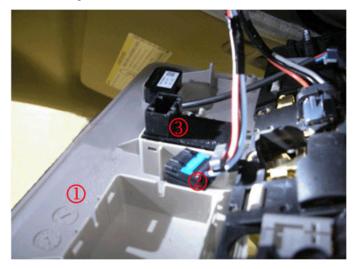
- 1. Overhead console
- 2. Beacon Switch Connector
- 3. Beacon Switch

When a roof beacon light is added the switch will need to be connected, see picture below. This is not covered under warranty and should be part of adding the roof beacon light.
