Bulletin No.: 16-NA-085

Service Bulletin

Subject: New Design Cylinder Heads

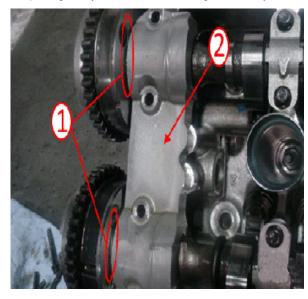
| Involved Region or Country | North America |
|---|--|
| Cause | The camshaft actuator thrust bearings may have caused damage to the cylinder heads, creating debris. |

Previously Designed Cylinder Heads used a thrust washer (1) between the actuators and cylinder heads.

If replacing the cylinder heads for damage caused by the thrust washers, the cylinder heads must be replaced with a newly designed cylinder head.

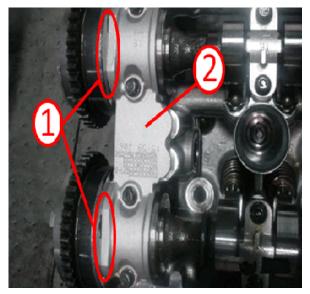
The new cylinder heads have a saddle cap (2), which incorporated a thrust surface on the saddle cap, has been designed to reduce the tolerance between the camshaft actuator and cylinder head, eliminating the need for a thrust washer.

Caution: If you are using a 2011 new style "saddle cap" cylinderhead, thrust washers are **not** to be used. The use of thrust washers on the new designed cylinder heads can cause damage to the cam shaft actuator, saddle cap and cylinder head.

If replacing the previous design cylinder heads with the newly designed heads, perform Cylinder Head Replacement per SI.
