Service Bulletin

PRELIMINARY INFORMATION

Subject: Oil Leak from Rear of Engine After Extended Driving in Cold Temperatures Below 0 F (-18 C)

Models: 2010-2012 Buick Lacrosse
2011-2012 Buick Regal
2010-2012 Chevrolet Equinox
2010-2012 GMC Terrain
with 2.4L Engine (RPO LAF or LEA)

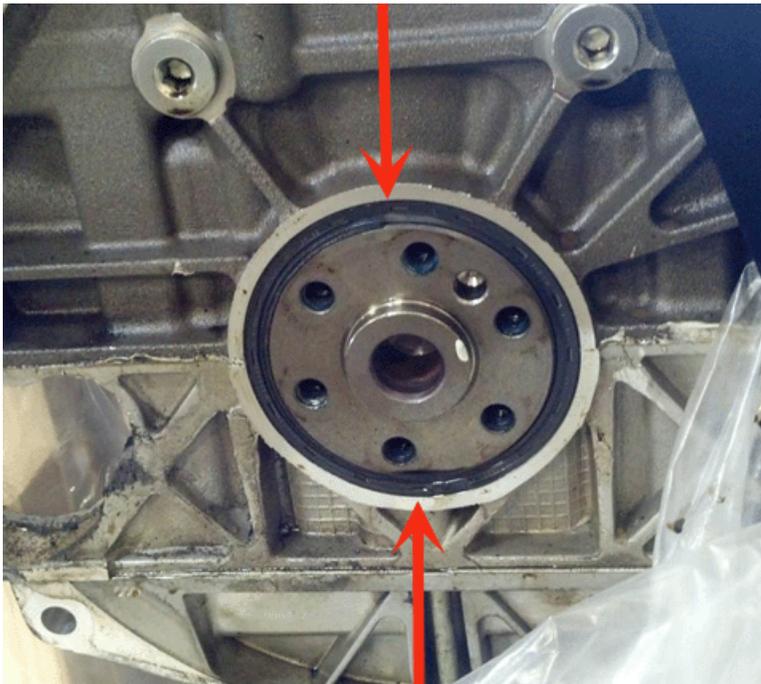
Some customers may complain of an engine oil leak that appeared as they were driving the vehicle in extremely cold ambient temperatures (Generally 0 F / -17 C or Colder). They may also comment that they heard a single "pop" noise right before the oil leak started. Upon inspection, the technician will find that the oil leak is coming from the rear main oil seal of the engine as shown below.

This may be the result of a frozen PCV system and excessive crankcase pressure. If a leaking rear main oil seal is found in warmer climates, this PI does not apply.

If this concern is experienced, determine if the concern is the result of a frozen PCV system by inspecting the PCV system, dipstick, and engine oil fill cap for signs of ice, moisture, and/or sludge build up.

1. Check for proper thermostat operation by following Thermostat Diagnosis as outlined in SI and replace the thermostat as necessary.
2. Remove the cam cover, inspect the PCV baffle inside, and replace the cam cover if obvious sludge build up is present.

3. Clean any ice/sludge/water out of the PCV pipes/hoses, the PCV nipple between the #2 and #3 intake runners, and the throttle body. Also inspect the related PCV hoses/connections for potential damage and replace if necessary.

4.) Allow the engine to idle at operating temperature for at least 15 minutes, turn the engine off, and drain the engine oil for at least 15 minutes to remove all oil and condensation/water from the crankcase.

5. Follow SI repair procedures to repair any oil leaks that were induced as a result of the frozen PCV system and excessive crankcase pressure.
6. Clean any oil residue left under the vehicle from the original oil leak.
