Service Bulletin

PRELIMINARY INFORMATION

Subject: SES Lamp On With DTC P2270

Models: 2013 Chevrolet Silverado
2013 GMC Sierra
Built with 4.8L 5.3L 6.0L RPO L20 LC9 LMG L96

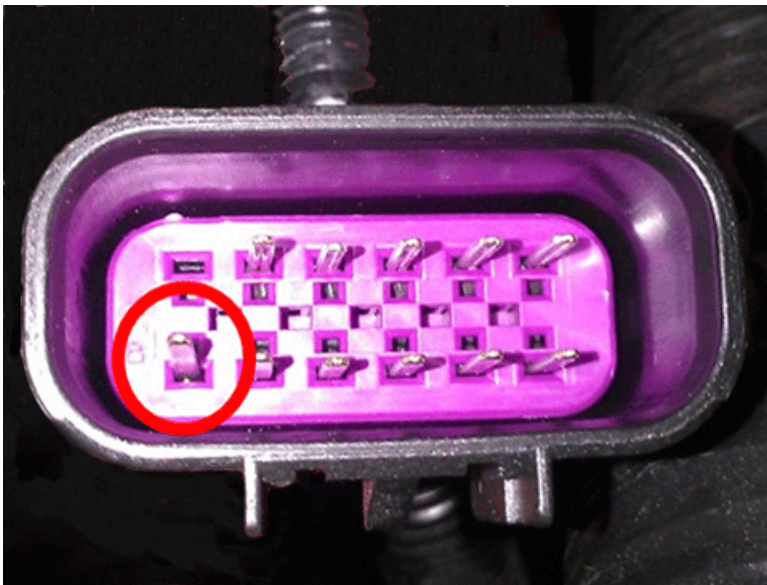
Concern of DTC P2270 setting along with any of the following codes P0140, P0139, P0138, P0137, P013A, P013B on vehicles built at the Fort Wayne assembly plant during February 2013.

Check connector X131 for a bent terminal F as indicated in the attached PIC and repair per SI procedures.

If no connector issue is found, follow SI diagnostics.
