Service Bulletin

PRELIMINARY INFORMATION

Subject: Black Bar On Left Side Of Display While On Bluetooth Audio Streaming Page Or USB Media Source

Models: 2014 GMC Sierra 1500 models
2015 GMC Sierra 2500/3500 models (without RPO AVF), Yukon models (without RPO AVF)
Equipped with RPO IO5 or IO6

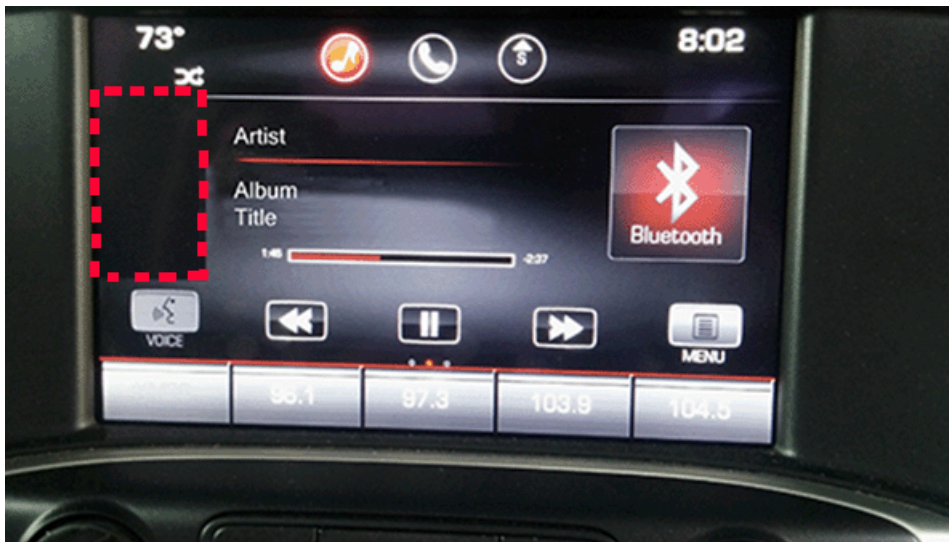
Some customers may comment about a vertical black bar (as shown in the picture below) while on the Bluetooth audio streaming source or while on the USB audio page:

No repairs should be made as a result of this concern. Please communicate to the customer this condition is a normal operating characteristic of their vehicle. It will not impact the designed performance or reliability of the vehicle. Please share this information with the customer, including a copy of this message.
