Service Bulletin

Subject: Headliner Wet, Water Leak from Front or Rear Sunroof Glass or Rear Compartment Carpet Wet

Models: 2008-2016 Buick Enclave
2009-2016 Chevrolet Traverse
2007-2016 GMC Acadia
2007-2010 Saturn OUTLOOK

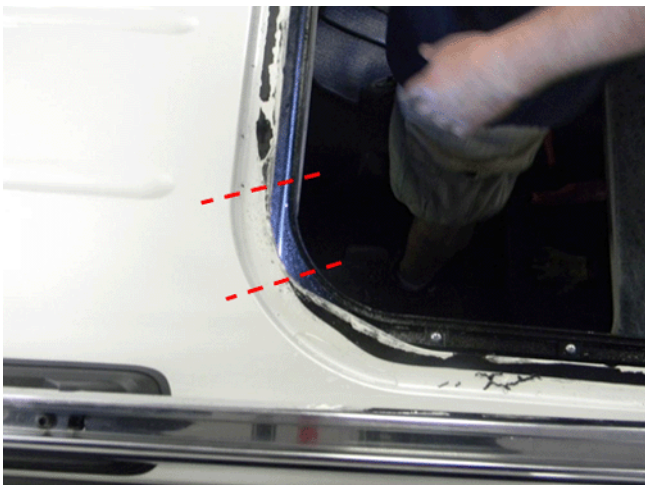
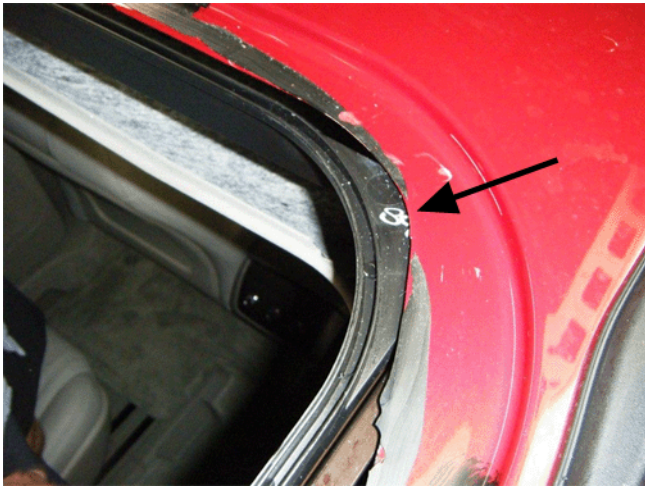
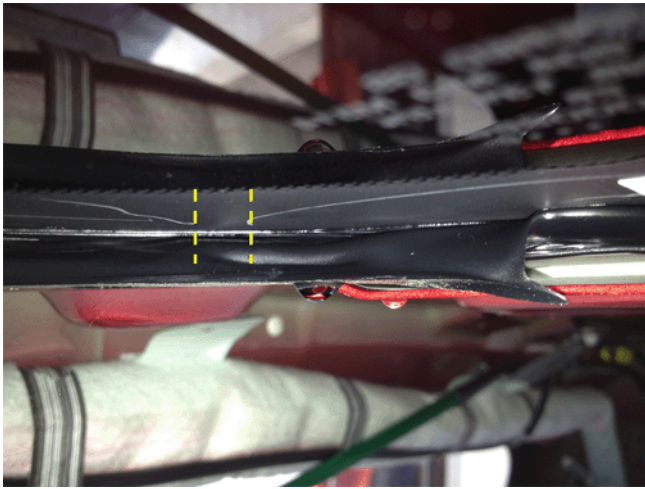
The cause of this condition may be from the urethane of the sunroof rear stationary window not sealing the glass to the body. This may allow water to leak between the urethane and roof flange, then onto the headliner.

To properly verify that the leak is from the sunroof rear stationary glass, use a soapy solution and compressed air. The more common areas where leaks may be found is at the center rear edge of the glass, or in the front or rear corners of the glass. Several examples are shown in the graphics below.

If a leak is confirmed, remove and reseal the glass. Refer to Roof Stationary Window Replacement in SI.

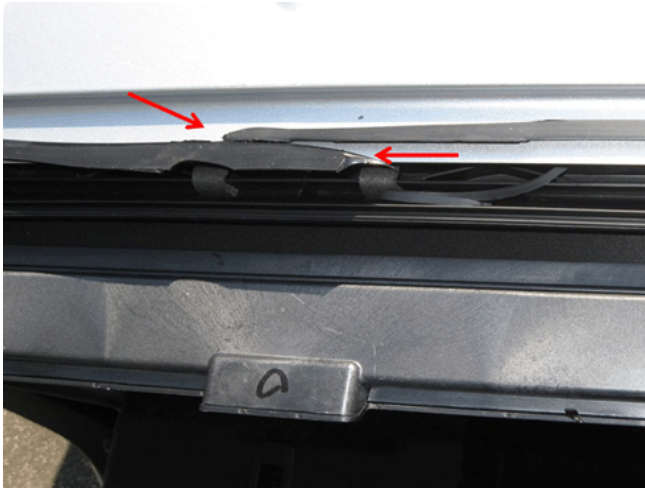
The graphic below shows an example of a leak caused by the urethane not being properly aligned.

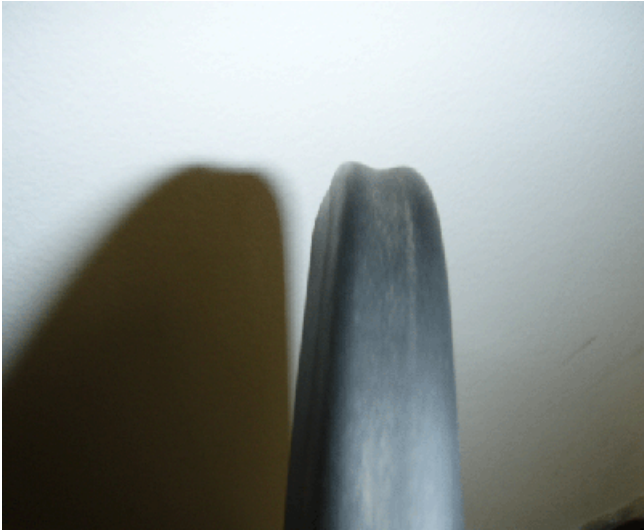
The sunroof glass panel weather-strip/seal may have failed to retain its designed shape, resulting in a water leak that overwhelms the sunroof module water trough or allows sufficient dirt and debris into the drain location to plug up the drains.

Technicians are to inspect the glass panel weather-strip/seal appearance at the corners and around the glass panel. If the seal looks depressed or concave in the middle, as shown above, replace the seal. Refer to Sunroof Window Weatherstrip Replacement in SI.

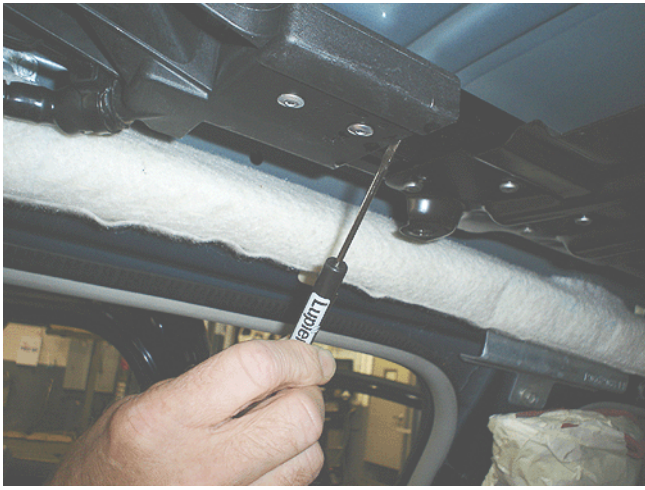
Important: All vehicles built prior to April 1, 2008 have drain holes in the roof sheet metal around the rear stationary glass. These holes are pierced through the roof structure and allow water to flow in to the vehicle. To confirm that water is entering through these holes, remove the sunroof frame and pour water around the rear fixed glass on the outside of the vehicle.

Important: Water dripping from the middle drain hose connection area, shown above, is due to the stationary glass holes leaking water, NOT the sunroof frame. Water flowing through these roof structure drain holes may miss the water management gutter, dripping onto the topside of sunroof frame and running to the underside of the frame where the black plastic drain spout attaches to the aluminum.

TECHNICIANS MUST SEAL THESE HOLES TO STOP WATER FROM ENTERING THE VEHICLE. ONCE THESE LOCATIONS ARE SEALED, NO WATER CAN ENTER THE VEHICLE IN THESE AREAS.

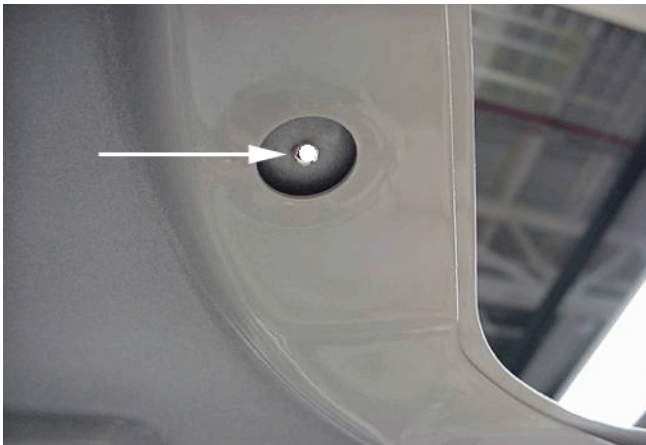
Note: The photo above, taken after the sunroof module was removed, is the view from inside the vehicle looking up at the drain holes around the rear fixed glass.

- Whether two or four holes are present, seal the holes in the roof sheet metal from inside the vehicle. Refer to the illustration above.

Important: When plugging the holes, make sure to use a windshield urethane sealant and NOT a silicone sealant. See the Parts Information section of this bulletin for the proper sealant.

Important: Ensure the urethane fills directly into the center of the hole (noted by the white area the illustration above) and pushes upward to completely seal the hole.

- Clean the four holes in the roof sheet metal and fill with a small amount of windshield urethane sealant.
- Reinstall the sunroof module.
- After the repair, run a second water test for leaks.

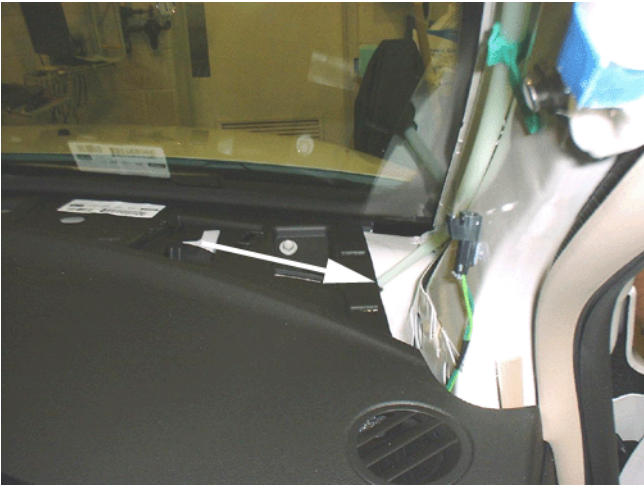
The cause of this condition may be that the end of one of the front drains may be plugged with grease from the sunroof, or debris may be caught in the cross hatch at the end of the drain tubes.

3. Remove the rubber grommet at the end of the drain tube. Refer to the illustration above.

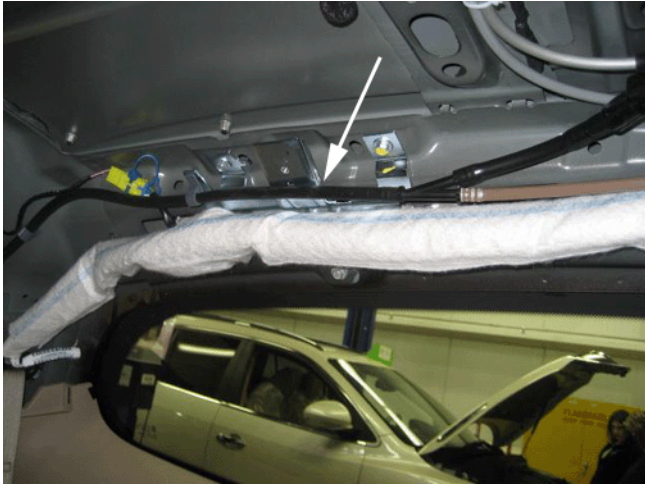
Figure 1 — Incorrect Routing

The cause of this condition may be a sunroof drain hose being improperly routed.

- Make sure that the hose is routed in back of the air bag bracket. Figure 1 shows the incorrect routing and Figure 2 shows the correct routing.
- Also make sure that there are no bends pointing upward in the drain tubes.
