Service Bulletin

PRELIMINARY INFORMATION

Subject: Slip or No Reverse or 3rd Gear, No Forward, DTC P0776

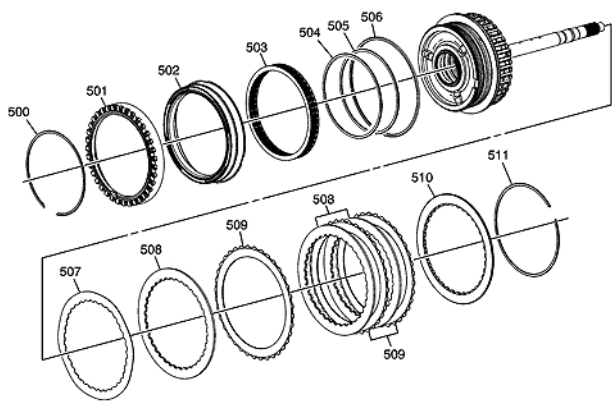
This condition may be caused by a broken 3-5-R apply (waved) plate (507).

Important: It is recommended that a new 3-5-R piston (503) and 3-5-R apply (waved) plate (507) be installed any time the transmission is disassembled for any reason.

Important: Debris generated by the condition must be cleaned from the entire transmission and the pump fluid filter (203) and the control solenoid filter plate

(8) must be replaced. These parts are included in the seal kit. Failure to separate the case halves, disassemble the transmission, clean the debris and replace the pump fluid filter and the control solenoid filter plate could lead to repeat transmission damage and repairs.

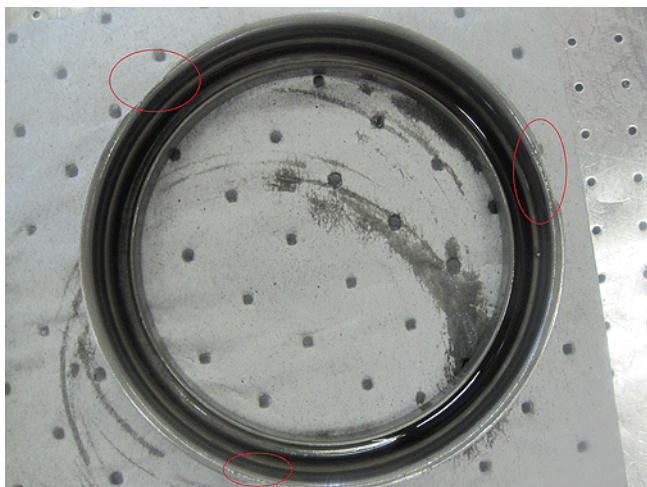
The notches in the 3-5-R piston (502), as shown in the photo below, were removed during the 2011 model year. Be sure to replace any 3-5-R piston with notches when repairing a broken 3-5-R apply (waved) plate or anytime the transmission is disassembled for service.
