Service Bulletin

Subject: Squeak Noise from Rear of Vehicle (Lubricate Rear Leaf Springs)

Models: 1999-2007 Chevrolet Silverado (Classic)
2007-2012 Chevrolet Colorado
2007-2015 Chevrolet Silverado
2015 Chevrolet Colorado
1999-2007 GMC Sierra (Classic)
2007-2012 GMC Canyon
2007-2015 GMC Sierra
2015 GMC Canyon
2007-2010 HUMMER H3, H3T

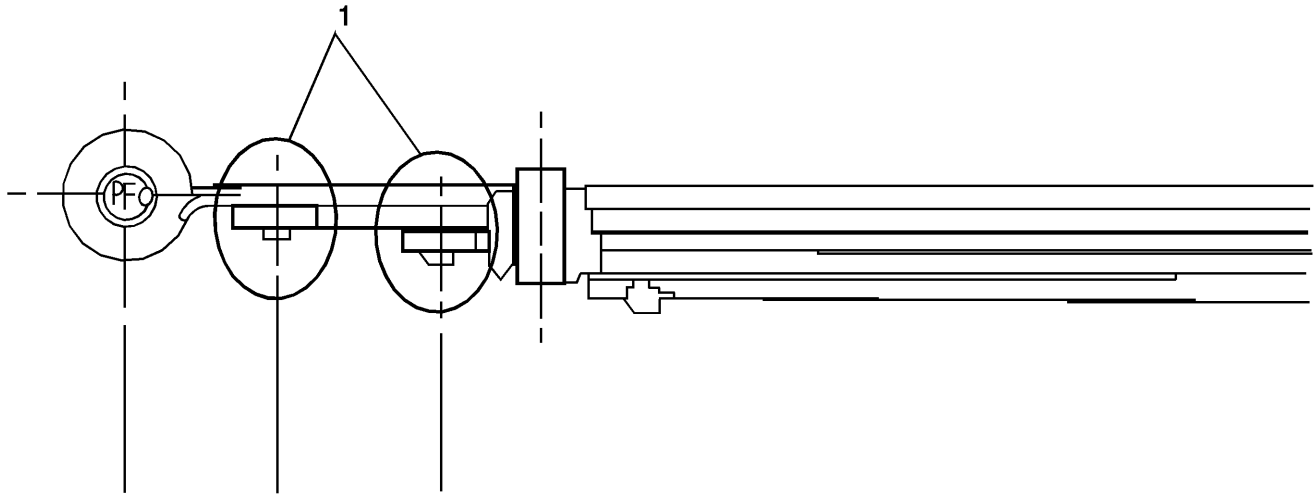
Some customers may comment about a squeak noise coming from the rear of the vehicle. During normal operation, certain vehicles may exhibit a squeaking noise that may be traced to the rear leaf springs. While this noise is an operating characteristic of leaf springs, the frequency and severity of this noise will be affected by the roads that the vehicle is driven on.

This condition may be due to debris getting between the leaf springs.

Note: Ensure any tool used to gently pry the tip inserts or spring leaves is protected to prevent damage to the spring leaves.

5. Apply a liberal amount of grease, P/N♦12345996 (in Canada, use P/N♦10953501), both underneath and on top of the front and rear tip inserts for the #2 and #3 leaves, as indicated below. A screwdriver can be used to gently pry up the tip insert; however, a rag around the screwdriver must be used to prevent damage to the spring. Use a flat-bladed tool, such as a gasket scraper to properly distribute the grease.
6. Lower the vehicle to the ground and test drive to verify the repair.
