# Service Bulletin

**Subject:** Aftermarket ALDL or DLC Interface Devices Causing Multiple Issues

**Models:** 2006-2016 GM Passenger Cars and Trucks

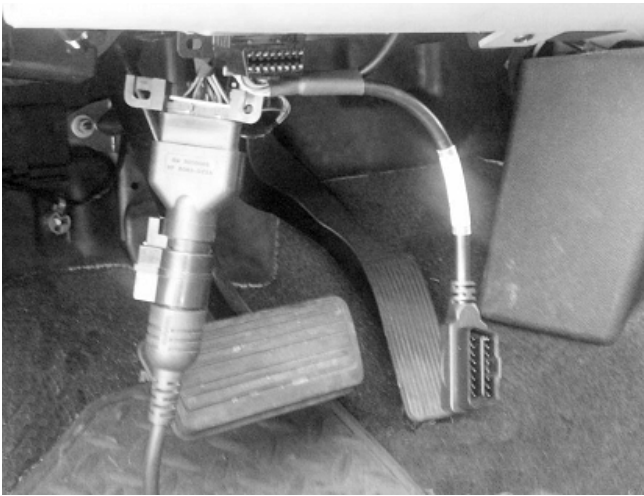
### Device W/Secondary DLC Connector

This device has another DLC connector on it. The rest of the harness along with the device can be placed out of sight hidden from the technician, who may not notice the diagnostic connector is not in the factory location.

If SI diagnostics do not identify the source of the issue and if the device is available, attempt to duplicate the condition, and then remove the device to determine if the condition is eliminated.
