Service Bulletin

PRELIMINARY INFORMATION

Subject: Water Intrusion - Forward Lamp Harness - Engine Cooling Fan Inoperative - DTC P0480 and/or P0691

Models: 2016 Chevrolet Camaro
Equipped with 3.6L engine (RPO LGX) and without RPO Y4Q

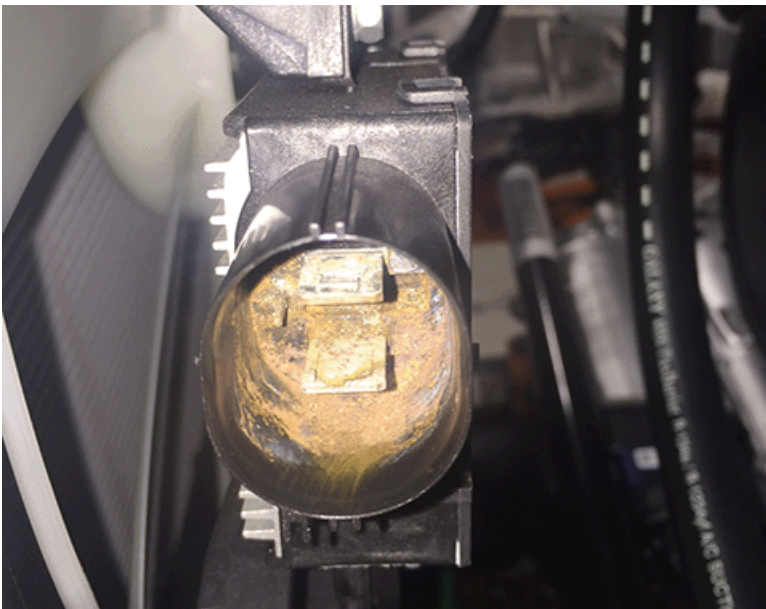
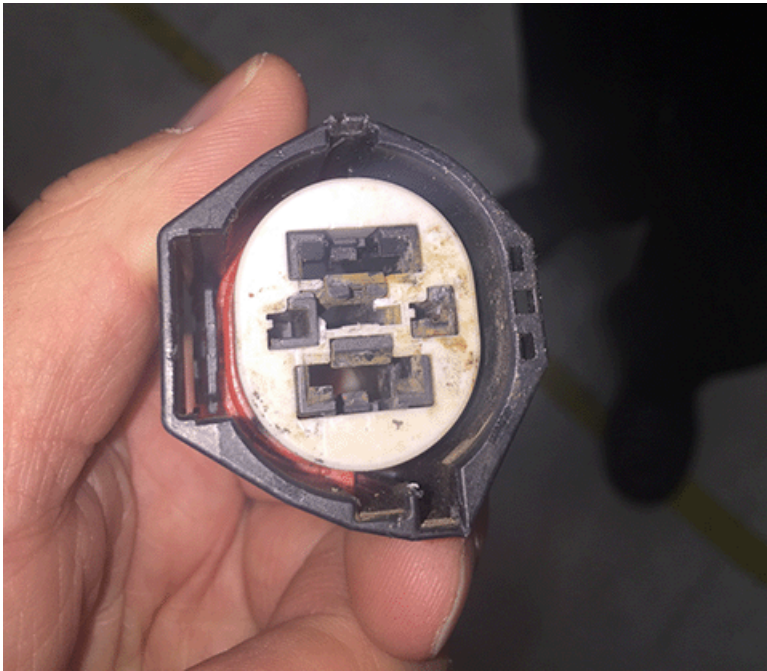
This concern may be caused by water intrusion into the forward lamp harness. If the wiring harness is stretched, or side loaded, where the cooling fan module connector plugs in, this may allow water to wick down the harness, past the weather pack seals, and into the connector itself. As time goes on, this water may corrode the terminals inside the connector and/or the harness itself as seen in the two photos below.

As the corrosion builds, this may cause the engine cooling fan to become inoperative altogether. If this concern is encountered, dealership technicians are to first inspect the forward lamp wiring harness to cooling fan module connector for the presence of moisture and/or corrosion. If water and/or corrosion is found, the fan control module and the forward lamp harness will both need to be replaced. If no water and/or corrosion is found after inspecting this connection, refer to Service Information (SI) and continue with regular diagnosis
