SUBJECT: Service Update for Inventory and Customer Vehicles
Incorrect Battery Current Sensor on Negative Battery Cable Assembly
Expires with Base Warranty

MODELS: 2013 Cadillac Escalade, Escalade ESV
2013 Chevrolet Tahoe, Suburban
2013-2014 Chevrolet Captiva, Captiva Sport
2014 Chevrolet Silverado
2013 GMC Yukon, Yukon XL
2014 GMC Sierra

Date: June 26, 2013

Subject: 13186 – Service Update Bulletin
Incorrect Battery Current Sensor on Negative Battery Cable Assembly

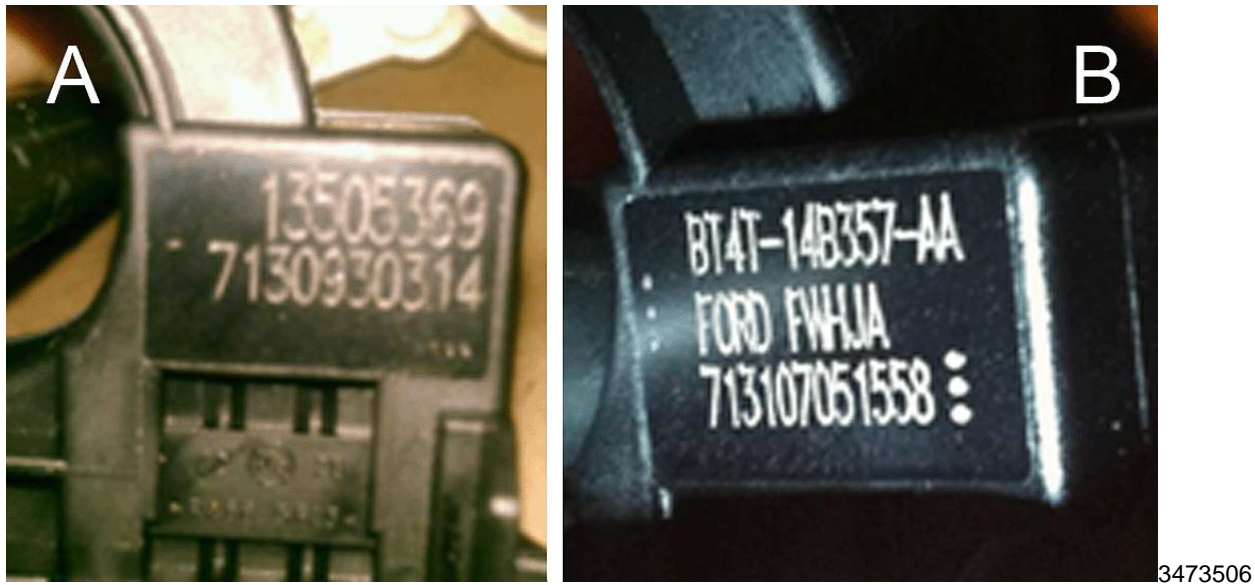
An incorrect battery current sensor may have been installed on the negative battery cable assembly. Perform the inspection procedure below to determine if an incorrect battery current sensor was installed.

Note: The battery current sensor part number is located on the backside of the sensor. Use a mirror and light to read the part number. If you cannot read the part number with a mirror and light, disconnect the sensor to read the part number. Refer to photograph. Portion 'A' of the photograph shows the correct part number for the battery current sensor. Portion 'B' of the photograph shows an incorrect part number for the battery current sensor.

3. Determine the part number on the battery current sensor.
 - If the battery current sensor part number is 13505369, the correct battery current sensor is installed on the negative battery cable. No further action is required.
 - If the battery current sensor part number is BT4T-14B357-AA, the incorrect battery current sensor is installed on the negative battery cable. Proceed to step 4.
4. Remove the negative battery cable from the vehicle. Refer to *Battery Negative Cable Replacement* or *Battery Positive and Negative Cable Replacement* in SI.
5. Install a new negative battery cable. Refer to *Battery Negative Cable Replacement* or *Battery Positive and Negative Cable Replacement* in SI.
