Service Bulletin

PRELIMINARY INFORMATION

Subject: Repeat P0521 And P06DD

Models: 2014-2015 Chevrolet Silverado
2014-2015 GMC Sierra
Built with a 4.3L LV3

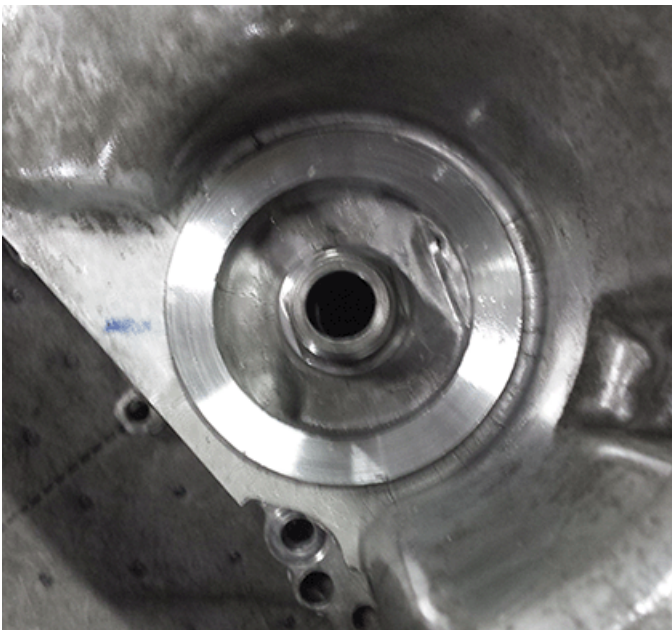
Some customers may comment on a SES with a DTC P0521 and or P06DD with a possible repeat of this concern.

This is an oil pan with the cast over passage

If you find a cast over passage concern, the oil pan will need to be replaced.

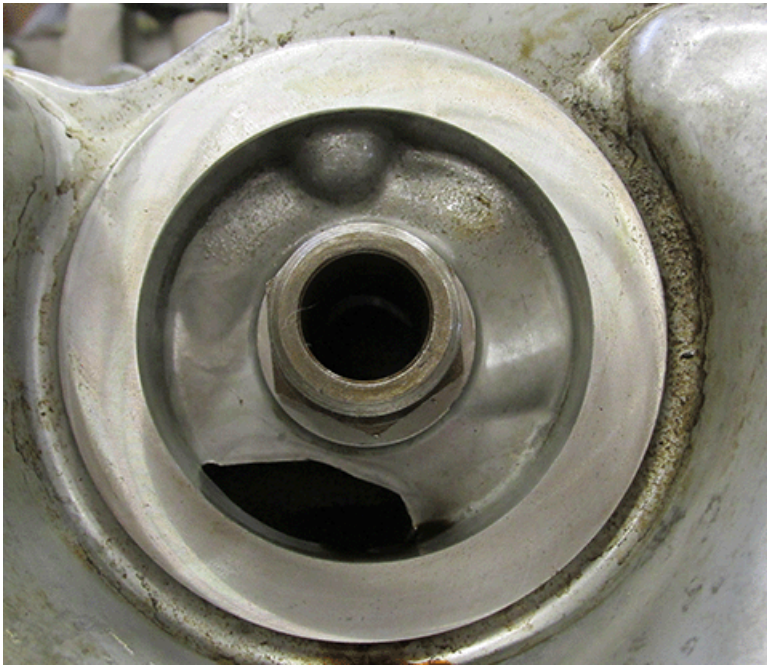
This is an oil pan without the cast over passage
