Service Bulletin

Subject: Installation Tip - Door Striker Cover Installation During PDI

Models: 2015-2016 Cadillac Escalade Models
2015-2016 Chevrolet Tahoe LTZ, Suburban LTZ
2015-2016 GMC Yukon Denali Models

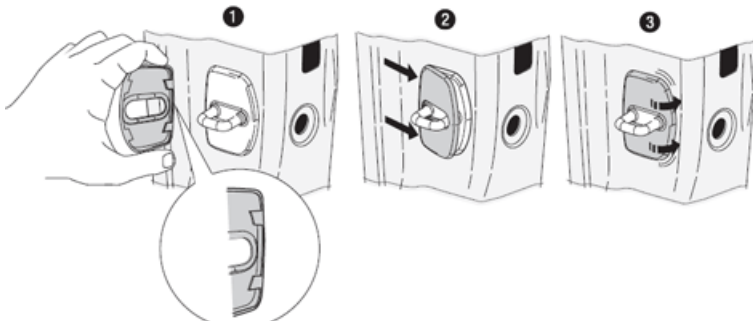
There have been reports of these covers being installed incorrectly / backwards.

Make sure the rounded side of the cover is positioned towards the outboard side of the vehicle, as reflected below:
