Service Bulletin

PRELIMINARY INFORMATION

Subject: Shake Or Shudder On Acceleration

Models: 2015 - 2016 Cadillac Escalade, Escalade ESV built prior to 11/01/15
2015 - 2016 Chevrolet Corvette, Silverado built prior to 11/01/15
2015 - 2016 GMC Sierra, Yukon, Yukon XL built prior to 11/01/15
Equipped with 8L90 Automatic Transmission (RPOs M5U) and the 6.2L (RPOs L86 and LT1)
Note: This information does not apply to Silverado and Sierra models with the 5.3L (RPO L83).
Please refer to bulletin 16-NA-175 for all other vehicles equipped with the 8L90 automatic transmission RPO (M5U) with shudder concerns.

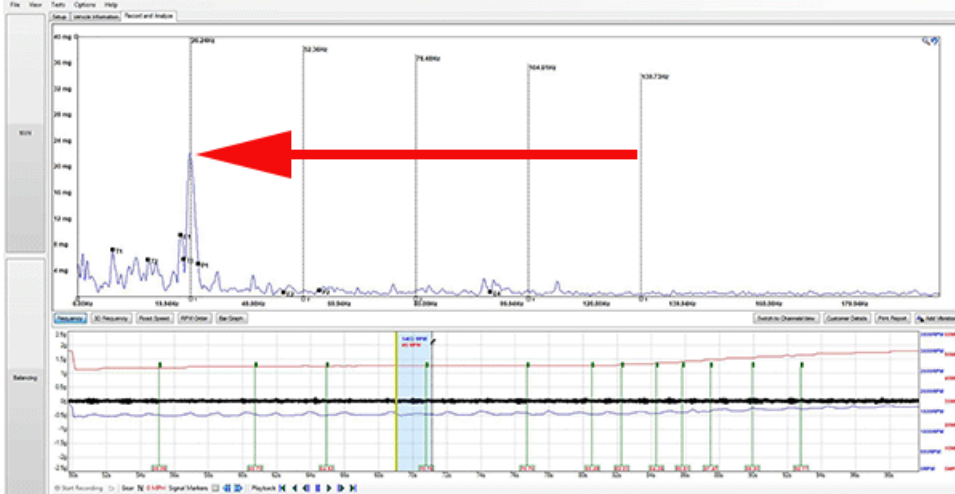
The disturbance will display as unknown and will be around 26 Hz at 16 to 24 mg as shown in the illustrations below if the concern is TCC shudder.

Note: If an engine 2 (E2) disturbance is noticed in the graph the engine most likely went into V4 mode.

In the above illustration frequency and default view have been selected.
