00280-01363 Version 2

MIL Comes On with DTC P0087

Supersedes 14-039, dated October 11, 2014, to revise the information highlighted in yellow.

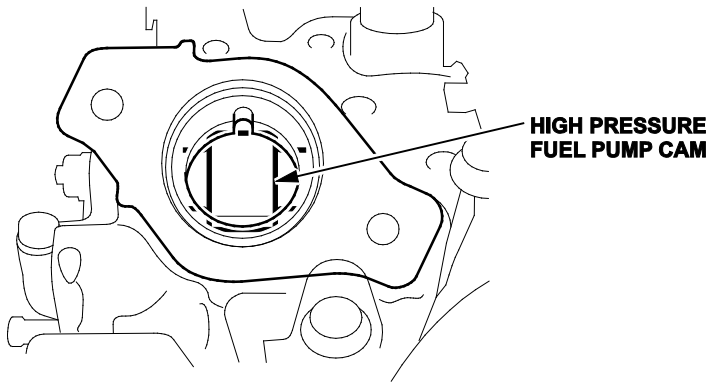
6. Turn the crankshaft and check the high pressure fuel pump cam for any pitting, scoring, or excessive wear. If needed, replace the fuel pump camshaft.
