January 22, 2015

01261-01378 Version 2

Safety Recall: Headlight LED Lens Film Delaminates

Supersedes 14-051, dated December 12, 2014, to revise the information highlighted in **yellow**

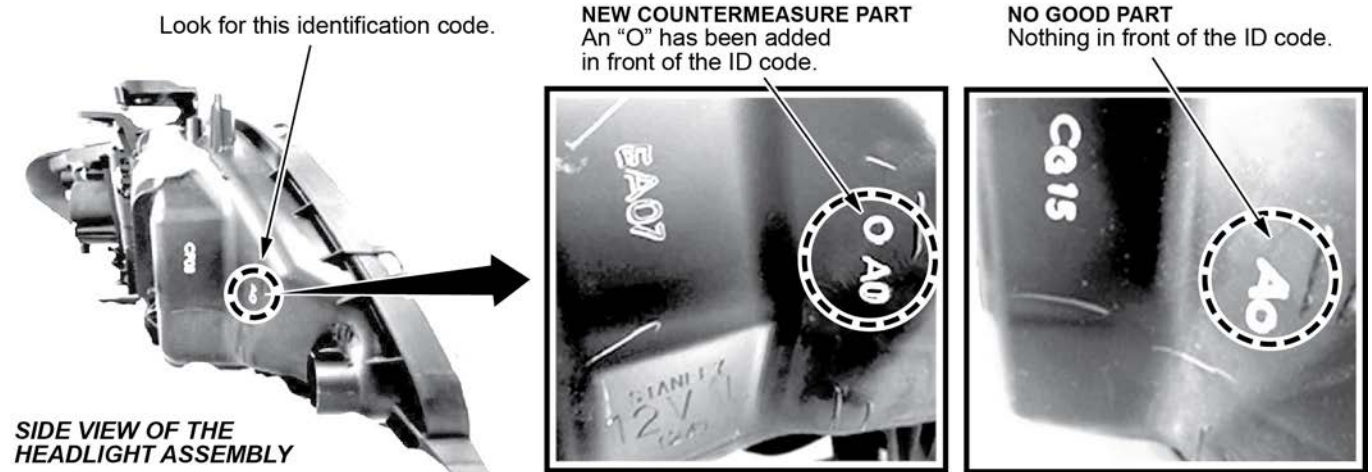
NEW IMAGE

NOTE: To differentiate the original head light assemblies from the improved ones, the improved assemblies have the letter "O" in front of the ID code.

5. Install the new headlights onto the corner upper beam and tighten the bolts to **9.4 N·m (6.9 lb-ft)**.
