Reference	SSM73202
Models	Discovery Sport / L550 Range Rover Evoque / L538
Title	L550 and L538 - HeVAC Unit Cracked - Water in Cabin
Category	Electrical
Last modified	16-Feb-2017 00:00:00
Symptom	208000 Climate Control
Attachments	Examples.pdf (Examples.pdf)

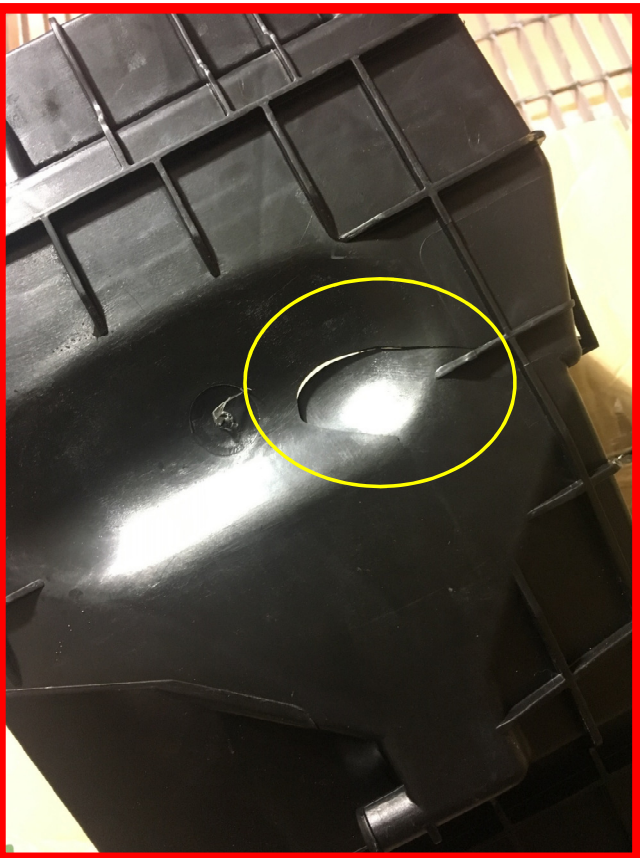
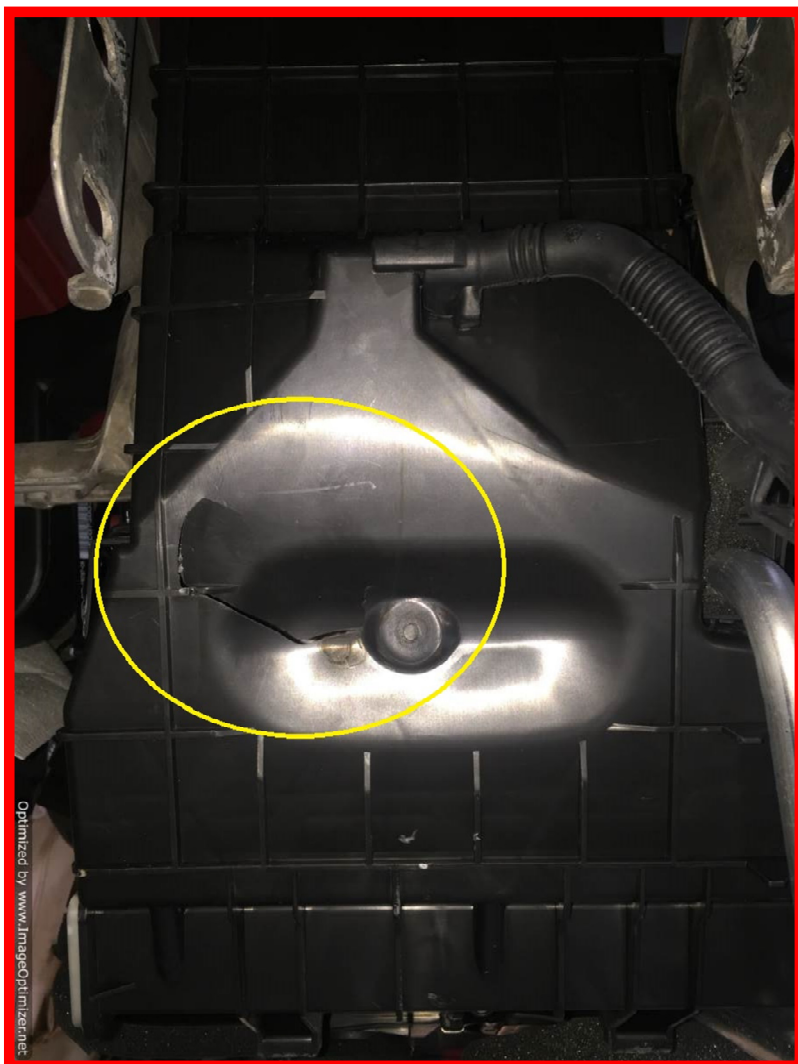
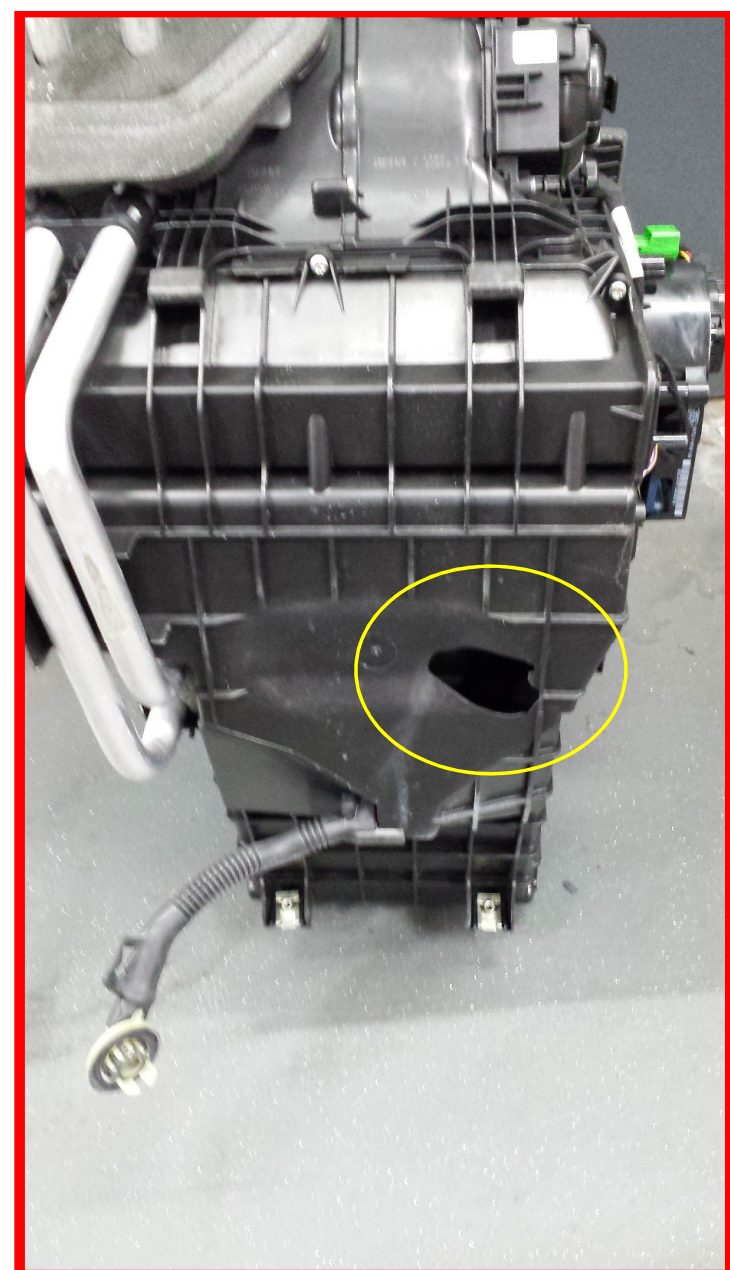
Further investigation reveals that the HeVAC drain tube is properly connected, but a crack is visible to the HeVAC Unit itself (see the attached images for examples).

Misalignment of the HeVAC Unit on the jig when assembled to the Instrument Panel during production, could have resulted in damage being sustained to the housing of the HeVAC Unit.

Confirm the customer concern and that the HeVAC Unit is damaged. Then:

- Replace the HeVAC Unit as per Topix section 412-01.

- Replace the HeVAC Unit as per Topix section 412-01.
- Raise an EPQR detailing the concern, any relevant checks/work carried out so far and images of the old HeVAC Unit.
