LTB01042NAS1

TECHNICAL BULLETIN

310-01C: Fuel Tank and Lines

Fuel Filler Hose Delamination

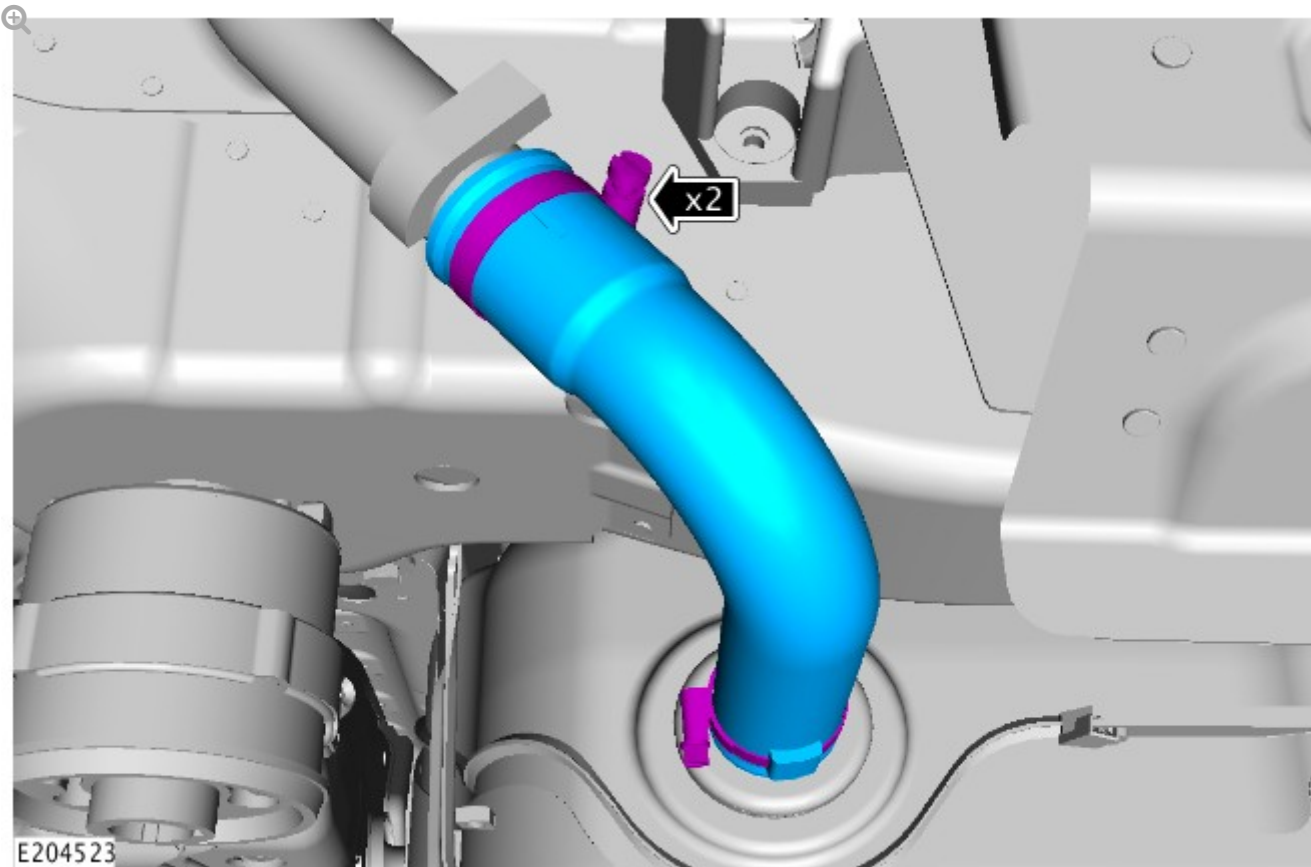
4

This may be caused by the fuel filler hose being delaminated internally.

Remove the fuel pipe.
