SERVICE BULLETIN

Classification: EC16-033a	Reference: NTB16-095a	Date: June 7, 2017
------------------------------	--------------------------	-----------------------

2016 TITAN XD; MIL ON WITH DTC P226C OR P0471 WHEN OPERATED AT OR BELOW 32°F (0°C)

APPLIED VEHICLES: 2016 Titan XD (A61)
APPLIED ENGINE: Cummins 5.0L V8 Diesel

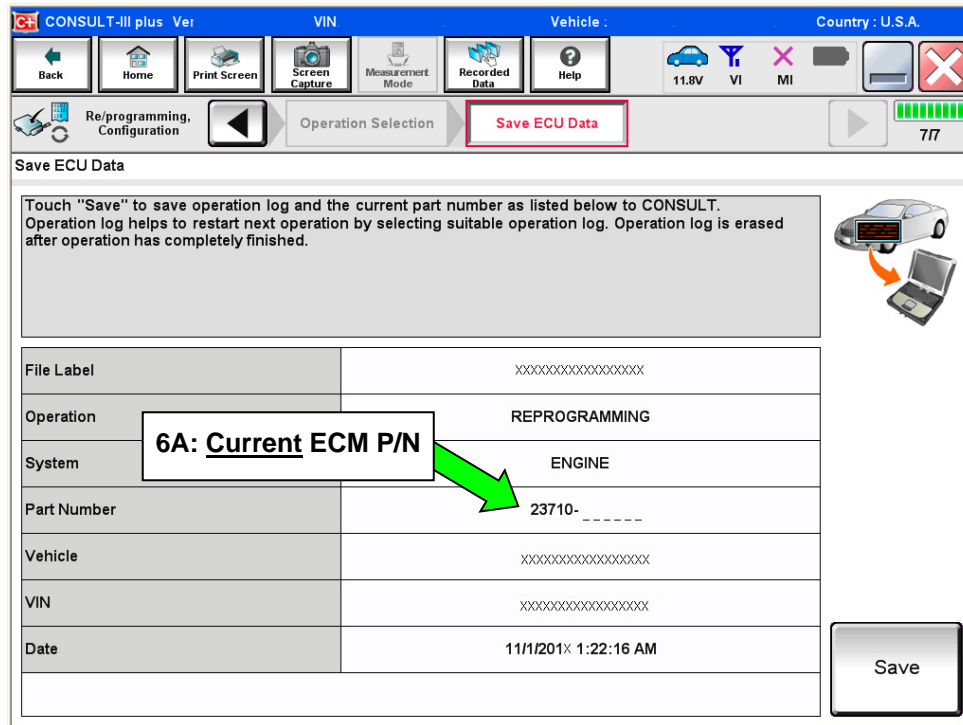
Figure 2

6. When you get to the screen shown in Figure 2, confirm this bulletin applies as follows.

A. Find the ECM **Part Number** and write it on the repair order.

B. Compare the P/N you wrote down to the numbers in the **Current ECM Part Number** column in **Table A** below.

- If there is a match, this bulletin applies. Continue with the reprogramming procedure.
- If there is not a match, this bulletin does not apply. Close C-III plus and refer to ASIST for further diagnostic information.

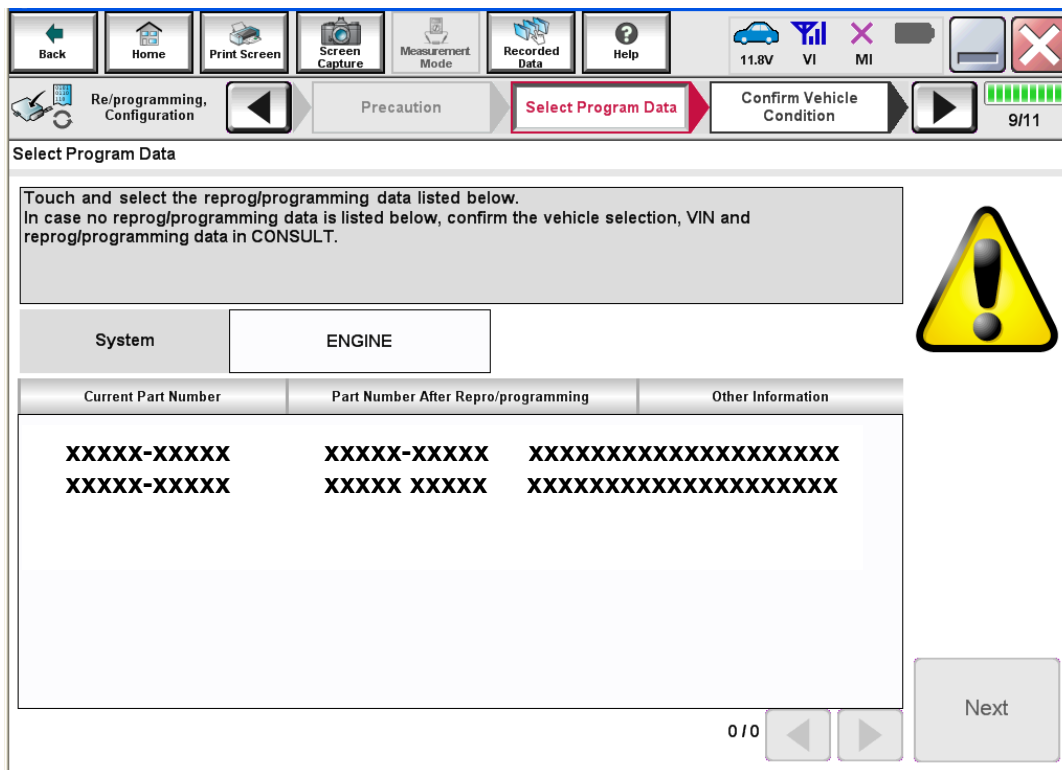
- In some cases, more than one new P/N for reprogramming is available.
 1. If more than one new P/N is available, the screen in Figure 3 displays.
 2. Select and use the reprogramming option that **does not** have the message “Caution! Use ONLY with NTBXX-XXX”.
- If you get this screen and it is blank (no reprogramming listed), it means there is no reprogramming available for this vehicle. Close C-III plus and refer back to ASIST for further diagnosis.

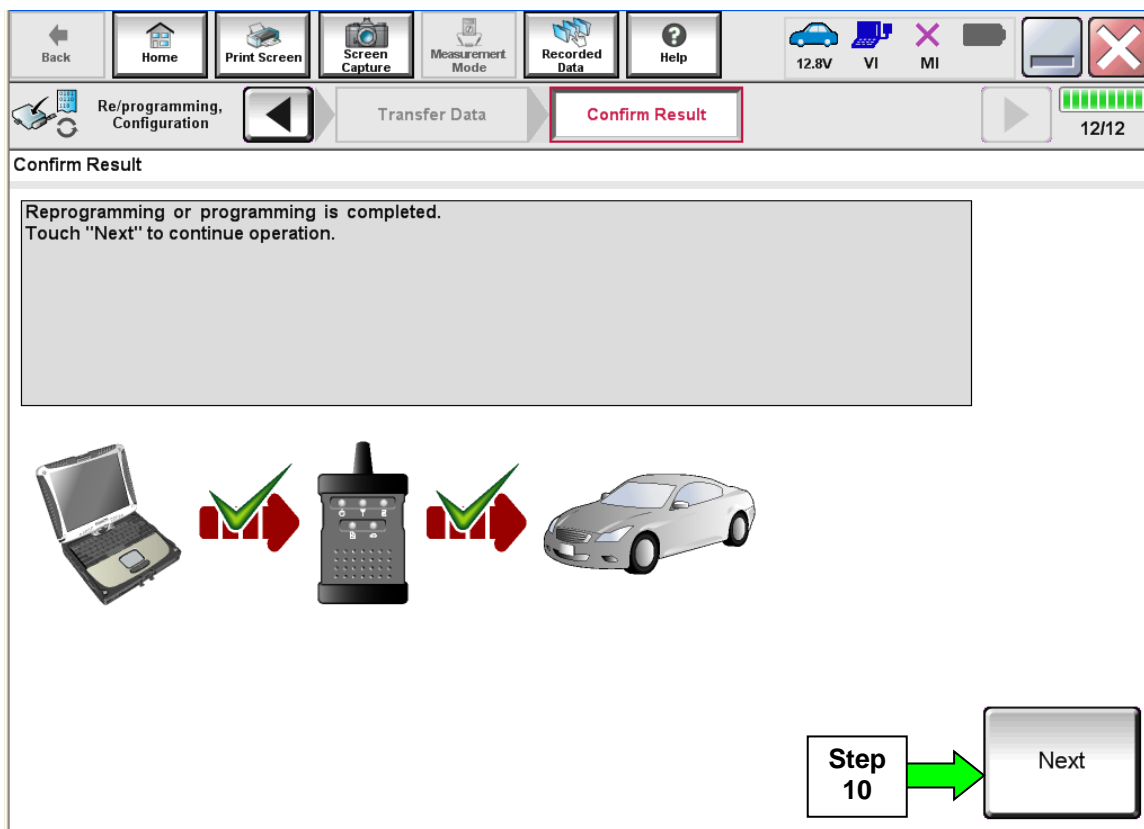
8. When the screen in Figure 4 displays, reprogramming is complete.

NOTE: If the screen in Figure 4 does not display (indicating that reprogramming did not complete), refer to ECM recovery on the next page.

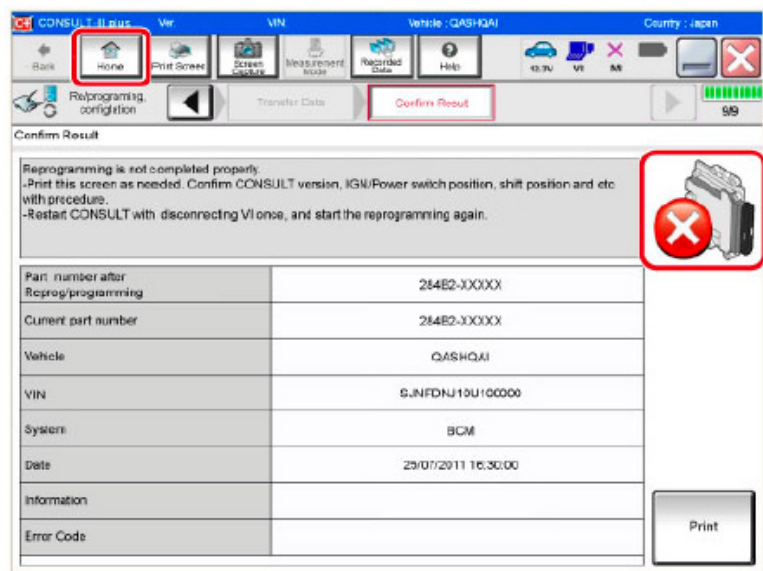
Figure 6

If reprogramming does not complete and the “X” icon displays as shown in Figure 6:

- Check battery voltage (12.0 - 15.5 V).
- CONSULT A/C adapter is plugged in.
- Ignition is ON, engine OFF.
- Transmission is in Park.
- All C-III plus / VI cables are securely connected.
- All C-III plus updates are installed.
- **Select Home, and restart the reprogram procedure from the beginning.**

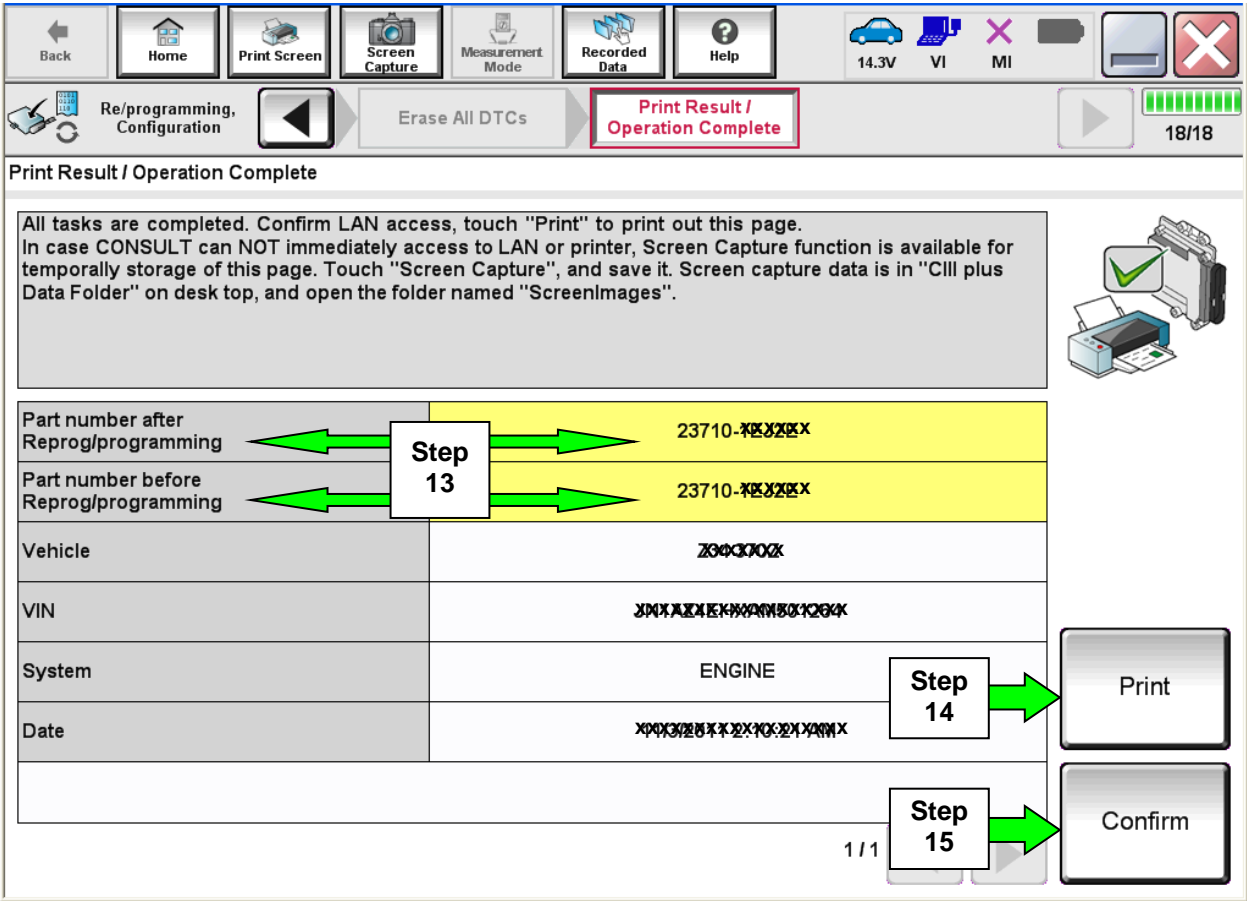
- 11. Follow the on-screen instructions to **Erase DTCs**.
- 12. When the entire reprogramming process is complete, the screen in Figure 7 will display.
- 13. Verify the before and after part numbers are different.
- 14. Print a copy of this screen (Figure 7) and attach it to the repair order for warranty documentation.
- 15. Select **Confirm**.
