## Technical Information Bulletin

### 34-058

C500/T800 Power Fuse Harness Cover

7/13/2017

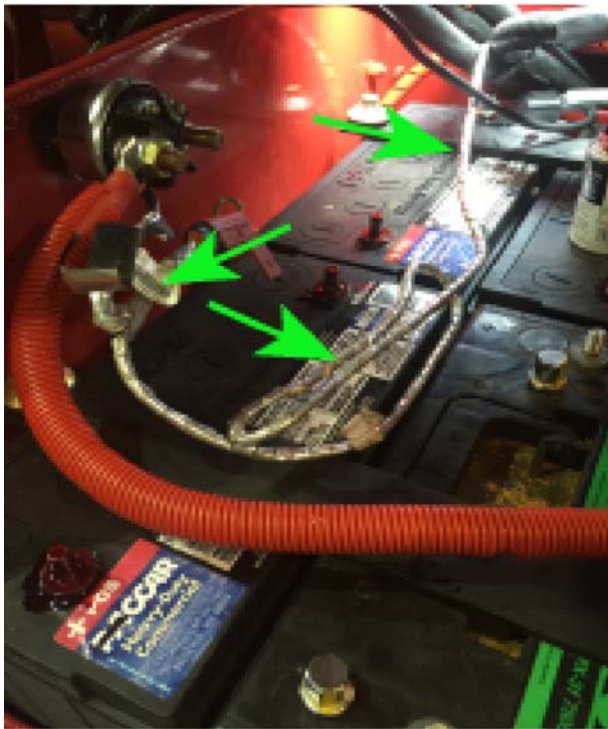
Some vehicles were equipped with a power fuse harness covered with an aluminum faced tape in the battery box area. There is a potential that a short to ground can occur while working in the battery box.

1. Disconnect the battery negative cable.
2. Remove the power fuse harness from the switch post.
3. Cut the cable ties that hold the harness to the battery cables.
