# Service Bulletin

**Subject:** EBCM Wheel Speed Sensor Diagnostic Aid for ABS Message - Click or Ratchet Noise - Service Traction Message - Service Stabilitrak Message - Service Steering Message

*This Bulletin replaces PIC5428G. Please discard PIC5428G.*

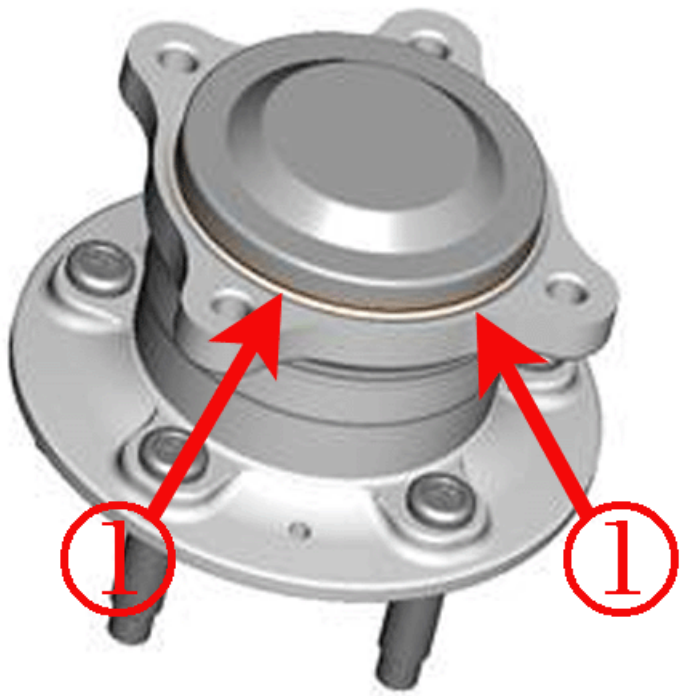
**Note:** THIS INFORMATION IS NOT APPLICABLE TO CAPPED WHEEL BEARINGS.

(1.) Capped Wheel Bearing

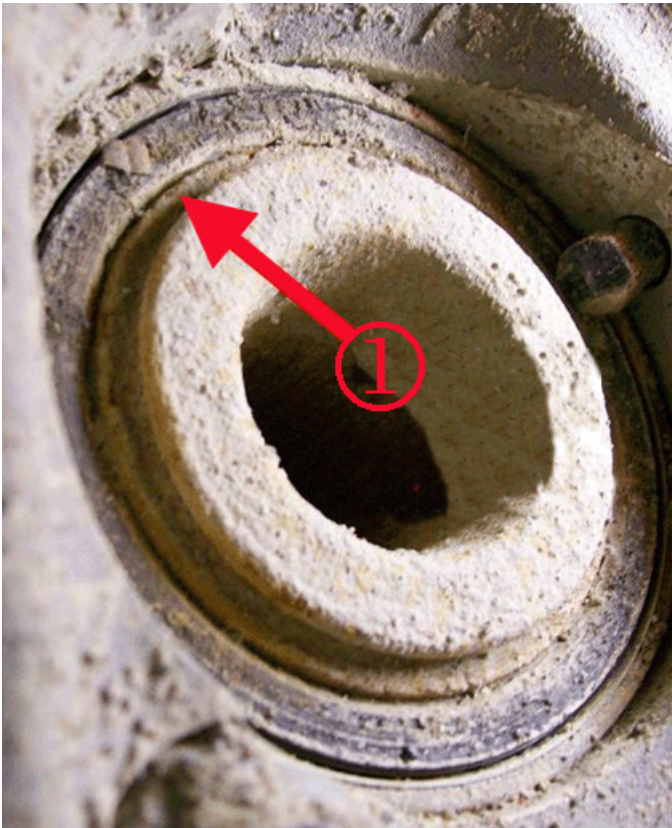
### BEFORE CLEANING

<b>Cause</b>	These conditions may be caused by single or multiple pieces of ferrous metallic debris stuck to the wheel speed sensor magnetic encoder ring.
<b>Correction</b>	Inspect and clean debris from the Encoder Ring.

(1.) Sample Debris

2.1. Gently using a dry nylon soft bristle brush, remove the foreign debris off the magnetic encoder ring. If debris was removed, proceed to step 3.

2.2. If debris still remains, wash the encoder ring using a mild soap detergent and wipe dry.
