JTB00570NAS1

# TECHNICAL BULLETIN

501-25A: Body Repairs - General Information

Creak Noise From the Rear of the Vehicle When Accelerating, Braking, and/or Cornering

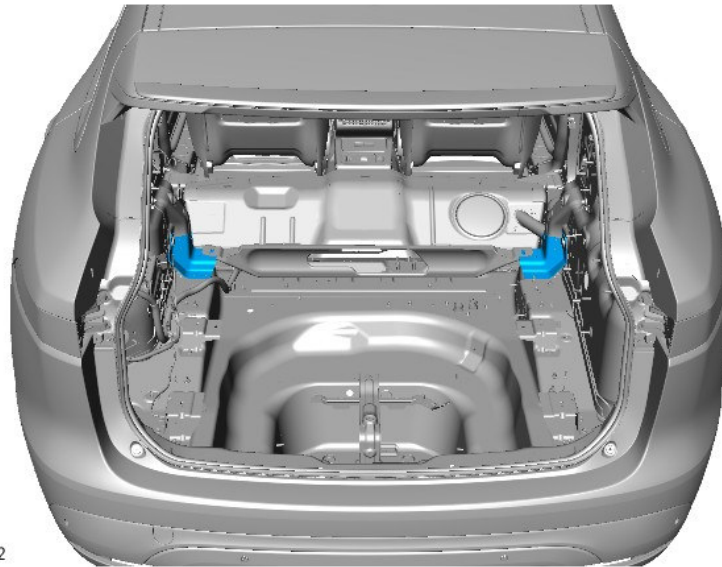
E208872

A creak noise may be evident from the rear of the vehicle when braking, accelerating, and/or cornering.

This may be caused by deformation of body panels.

Location of the repair.
