JTB00518NAS5

TECHNICAL BULLETIN

303-03 - Engine Cooling

Engine Coolant Expansion Tank Leak

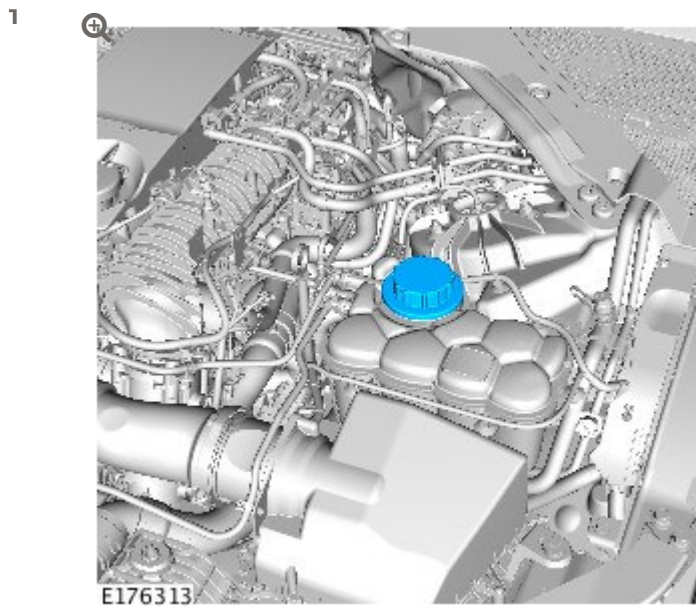
Remove the engine coolant expansion tank pressure cap.

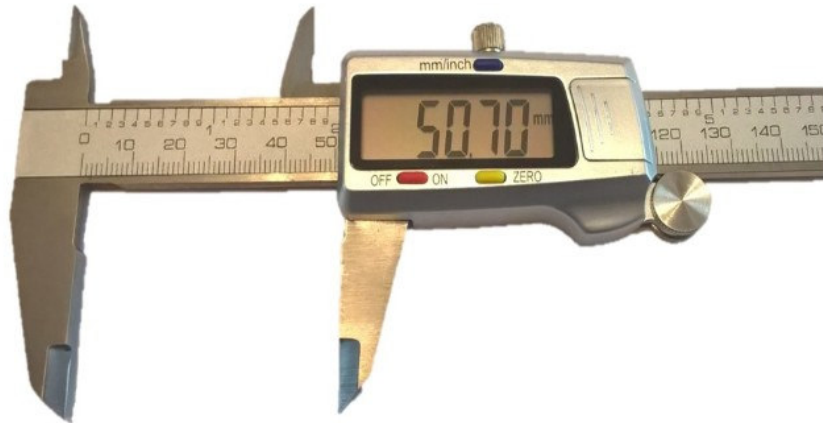
E196112

Set a vernier caliper to 50.70mm.

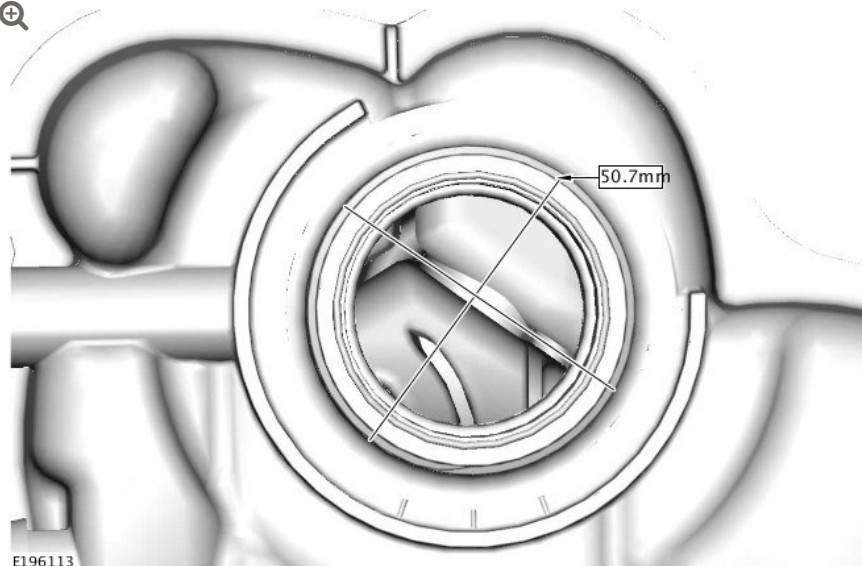
E196113

Check the dimensions of the engine coolant expansion tank threaded neck in the two positions shown.

- If the dimensions across the centerline neck are less than 50.70mm, go to Step 5.
- If the dimensions across the centerline of the neck are 50.70mm or greater, go to Step 4.

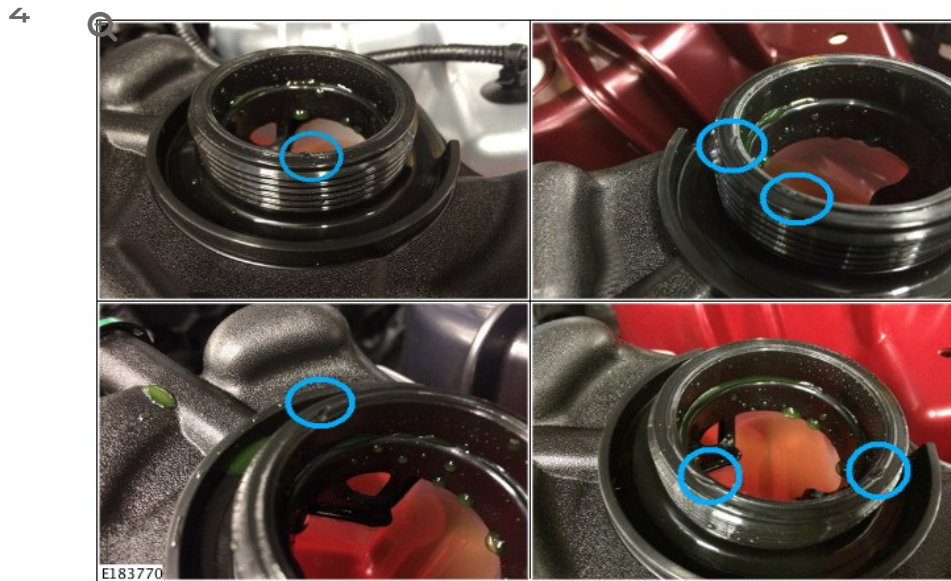
Visually inspect the sealing bead on the engine coolant expansion tank neck to check for damage.

- If the sealing bead is damaged, go to Step 5.
- If no damage is found:
 - Install a new engine coolant expansion tank pressure cap.
 - Top up the engine coolant to the MAX level mark.
 - Run the engine up to normal operating temperature, allowing the electric cooling fan to operate at least once without problem before releasing the vehicle.
 - Switch the engine OFF.
