JTB00568NAS2

TECHNICAL BULLETIN

501-03: Body Closures

Rattle From Front Door(s)

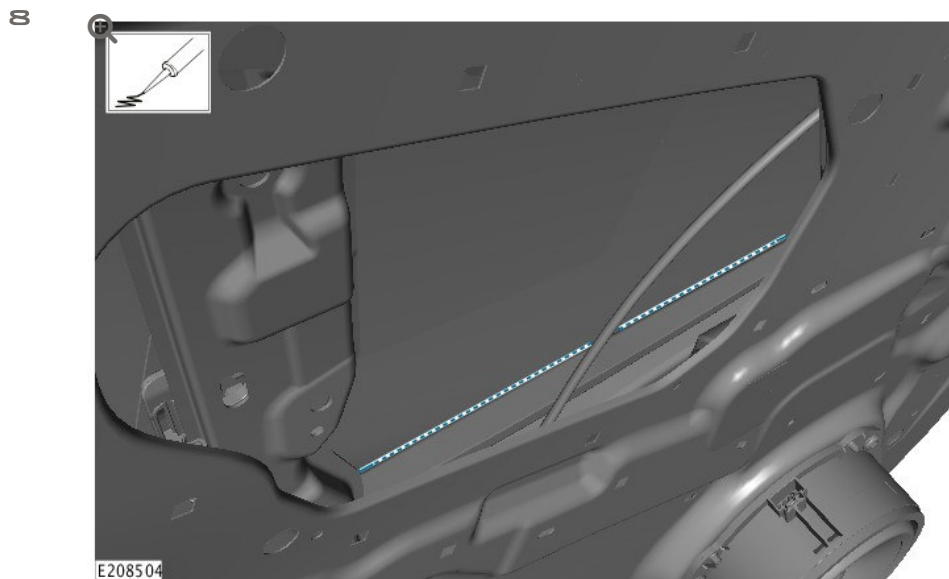
A rattle/knock noise may be evident when closing the front doors or driving slowly over rough ground.

This may be caused by the front left and/or right door side protection bar bonding detaching from the inner door panel.

Apply elastic PU adhesive/sealant (Wurth Bond and Seal Adhesivflex - 08901001 [or equivalent]) along the door side protection bar as shown.
