JTB00461NAS2

# TECHNICAL BULLETIN

501-12: Instrument Panel and Console

Sunglasses Holder Will Not Open/Close

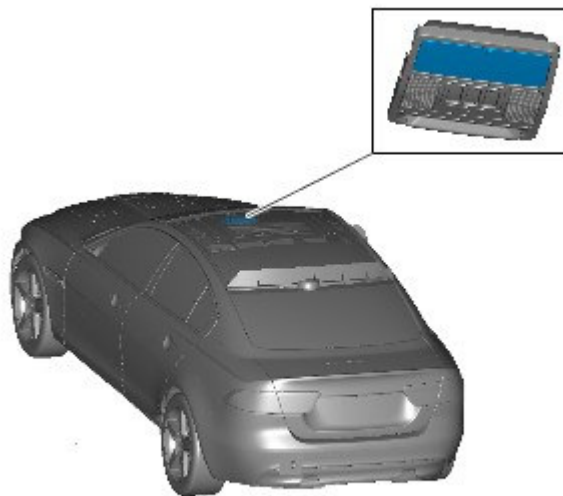
E184931

The front overhead console sunglasses holder may appear to be distorted and will not latch correctly in certain conditions.

This may be caused by hinge pin distortion, allowing the cam mechanism to be displaced and become inoperative.
