GROUP BOD	MODEL 2017MY Sportage (QL)
	NUMBER 152 (Rev1 12/5/2016)	DATE December 2016
TECHNICAL SERVICE BULLETIN		
SUBJECT:	SERVICE ACTION: DELTA GARNISH AND FRONT BUMPER GAP/WIND NOISE ADJUSTMENT (SA248)

This bulletin provides the information for applying soundproof padding to the Delta Garnish on 2017MY Sportage (QL) vehicles produced from December 10, 2015 through October 14, 2016, and to inspect the front bumper and, if necessary, apply soundproof padding on some 2017MY Sportage (QL) vehicles produced from July 8, 2016 through August 30, 2016. Kia is requesting the completion of this Service Action on all affected vehicles in dealer stock, prior to delivery. Before conducting the procedure, verify the vehicle is included in the list of affected VINs.

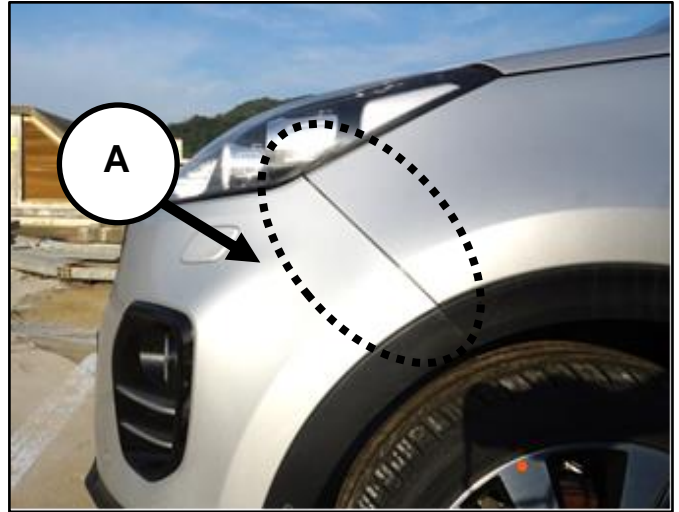
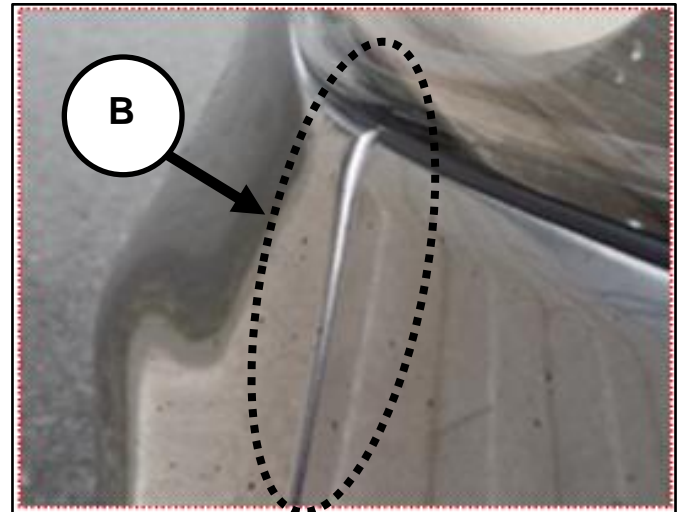
Example of poor fitment/flushness (B).

4. For vehicles produced from July 8, 2016 through August 30, 2016 only (identified as SA248B), inspect the LH/RH (A) front bumper to fender joint areas for proper fitment or gaps. Apply soundproof padding if poor fitment or gaps are found (B).

If the bumper fitment is found to be OK, no further action is required.
Close the repair.

If the bumper repair is necessary, proceed to next section "Soundproof Padding Application to the Front Bumper."
