LTB01060NAS1

# TECHNICAL BULLETIN

501-11: Glass, Frames and Mechanisms

## Power Windows Inoperative

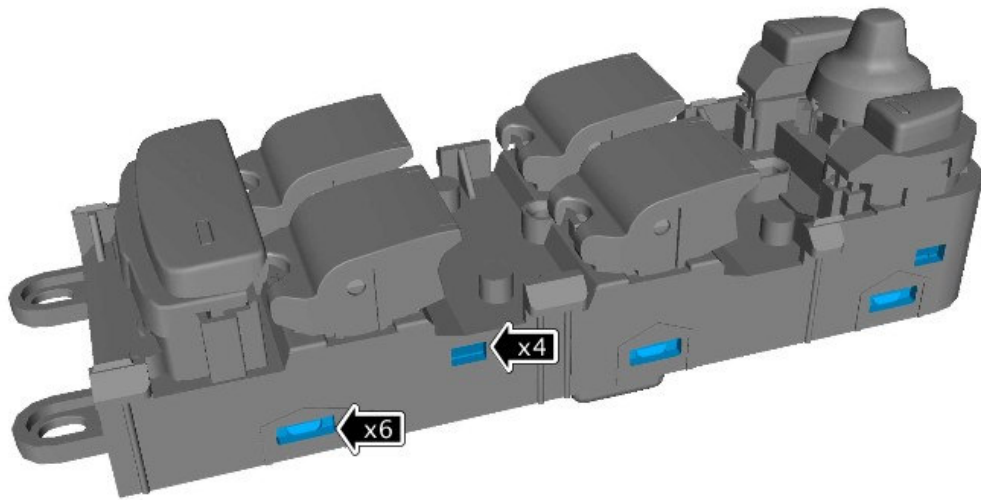
E207688

This may be caused by old stock driver door window switchpacks not having the required sealing tape installed, leading to water ingress.

Apply sealing tape to both sides of the **new** driver door (master) window switchpack, covering the side cavities on the driver door switchpack.
